## DAMAGE INVESTIGATION ON WELD ALUMINUM COMPONENT OF A COMPRESSOR AFTER-COOLER

**Dewa Nyoman Adnyana**

#### Studi Kerusakan Sambungan Las Komponen Aluminium Sebuah Alat Penukar Kalor Kompresor

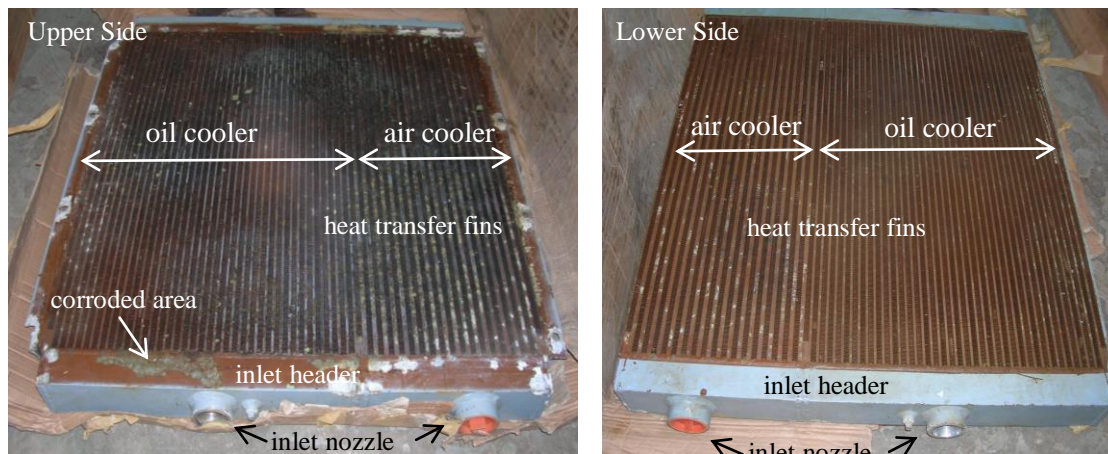
compressor air cooler and compressor lubricating oil cooler. The operating data of the compressor after-cooler is as follows: duty of 897 BTU/min., and maximum working pressure of 150 psig. As indicated in Figure 1, the leak is located at the oil cooler around the corroded area on the weld joint between the inlet header and the side bar/parting sheet.

Figure 1. The leaked compressor after-cooler used in the present study, showing its upper side and lower side, respectively.

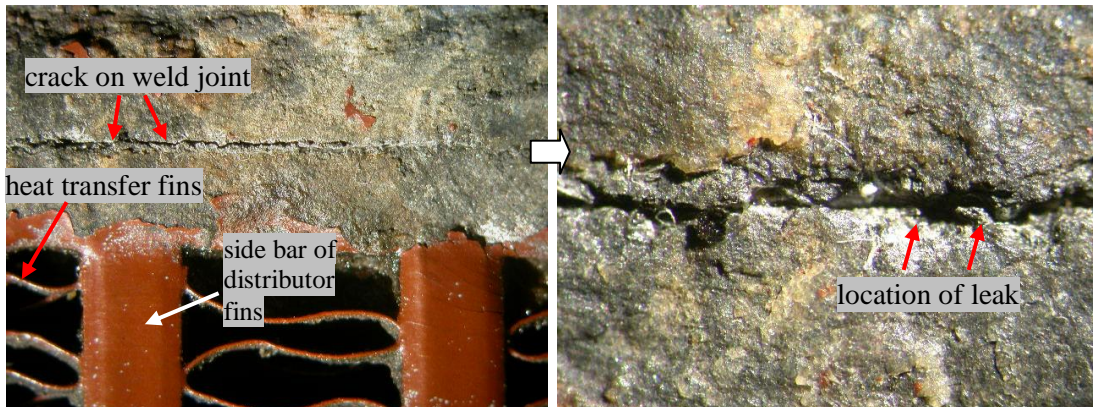
A close up view of the failed after-cooler shown in Figure 4 reveals that the oil leak located on the linear crack that formed on the

parting line of weld joint between inlet header and side bar/parting sheet.

Figure 4. Close up view of the corroded surface around the weld joint of the leaked compressor after-cooler.

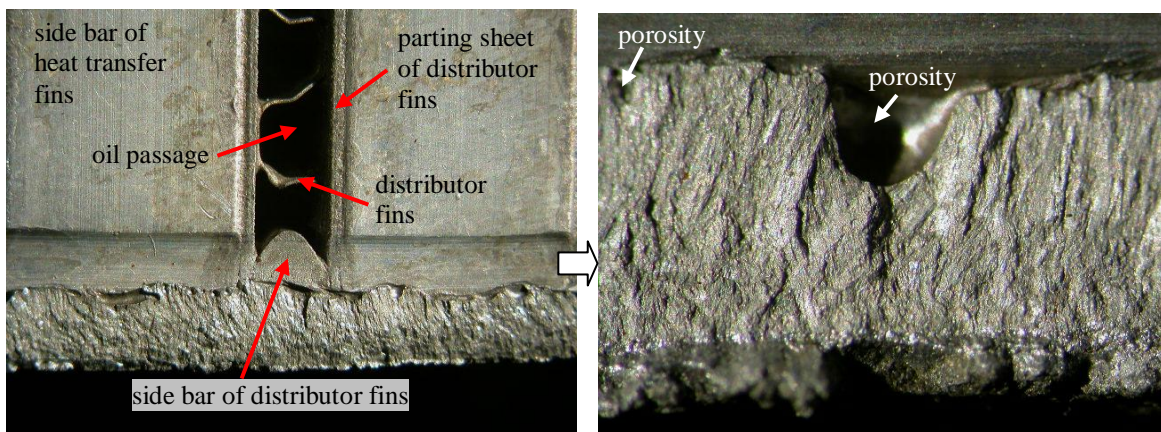
The results of macroscopic examination obtained from the leaked area on the weld joint between the inlet header and the side bar/parting sheet of the compressor after-cooler (see Figure 4) are presented in Figure 5. It can be seen from Figure 5 that most of the weld

fracture surface apparently contained a number of voids due to gas porosity. In addition, the corrosion seems to have entered into the weld fracture surface. Beside that, the application of one single fillet weld may have further reduced the load-carrying capacity of the weld joint between the inlet header and the side bar/parting sheet and therefore it was prone to cracking.

Figure 5. Fracture surface of the weld joint between header and side bar/parting sheet

In addition to the external corrosion and weld defect, the premature failure of the compressor after-cooler was also likely caused by insufficient weld design as the weld joint between the header and the side bar/parting sheet of the after-cooler only used a single fillet weld. The application of another fillet weld on the inside parting line between header and side bar/parting sheet may improve the load carrying capacity of the weld joint structure, and hence it may increase the operating life of the after-cooler significantly.

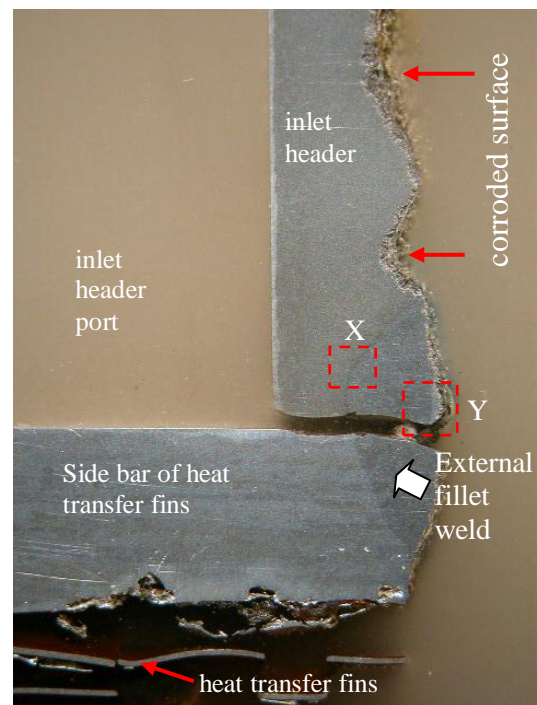
Figure 6 shows a cross-section of a polished and etched specimen obtained from the leaked weld joint between the inlet header and the side bar of the after-cooler/oil cooler. The specimen shows a fracture line lied along the parting line between the header and the side bar of heat transfer fins. The crack leading to fracture was likely originated from the corroded weld surface. Microstructures obtained from the specimen shown in Figure 6 are presented in Figure 7 at different locations. In the weld joint of the header side shown in Figure 7a, the microstructures obtained are located around the weld metal (WM), heat affected zone (HAZ) and around the base metal (BM). The microstructure of weld metal generally shows a dendritic type, while the microstructure of the header material at its base metal shows typical wrought aluminum alloy microstructure containing fine particles of the intermetallic second phases [1,2,8-10]. Similarly, the microstructure obtained from the weld metal shown in Figure 5 also apparently exhibits a number of large voids or porosity (see Figure 7b). This further confirms that the fillet weld between the inlet header and the side bar/parting sheet of the compressor after-cooler contained some amount of weld defect. In addition, the microstructures shown in Figure 7b also exhibit the area with heavy damage of external corrosion. The corrosion damage on the weld metal surface in general shows typical interdendritic corrosion. This interdendritic corrosion may have been caused by sensitization that occurred on the weld metal due to formation of a number of intermetallic phases during welding process or in service at extended high temperature exposure [1, 2, 8, 10].

Figure 6. Cross section of a polished and etched specimen obtained from the leaked weld joint between header and side bar/parting sheet

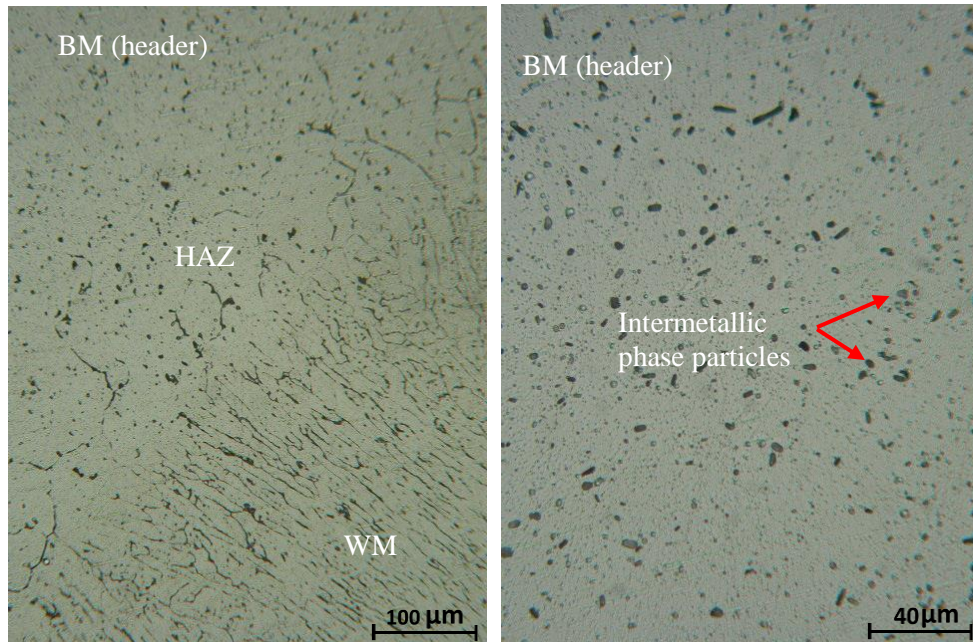
Figure 7a. Microstructure obtained from the weld joint between header and side bar/parting sheet at location X as indicated in Figure 6 (etched with Keller solution). Note BM is base metal, HAZ is heat-affected zone, and WM is weld metal.

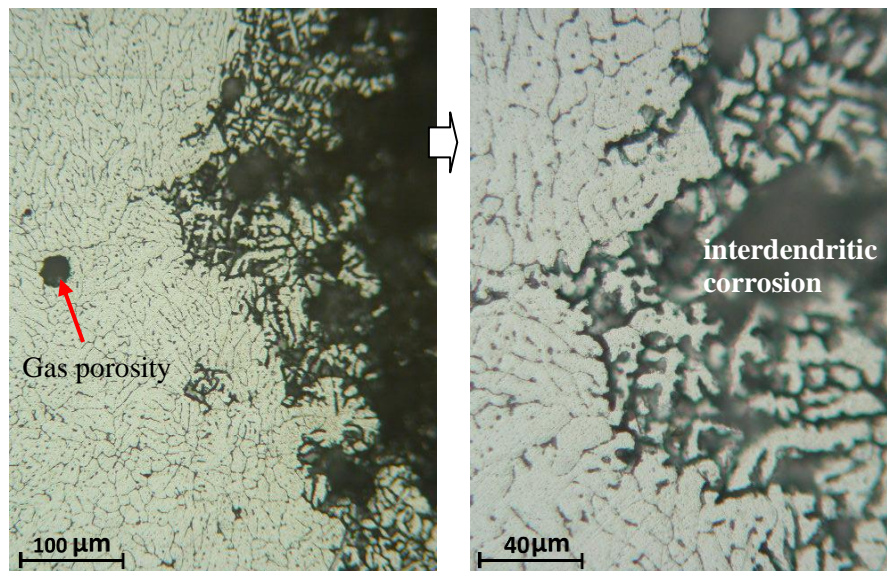
Figure 7b. Microstructure obtained from the corroded weld metal of the header side at location Y as indicated in Figure 6 (etched with Keller solution)

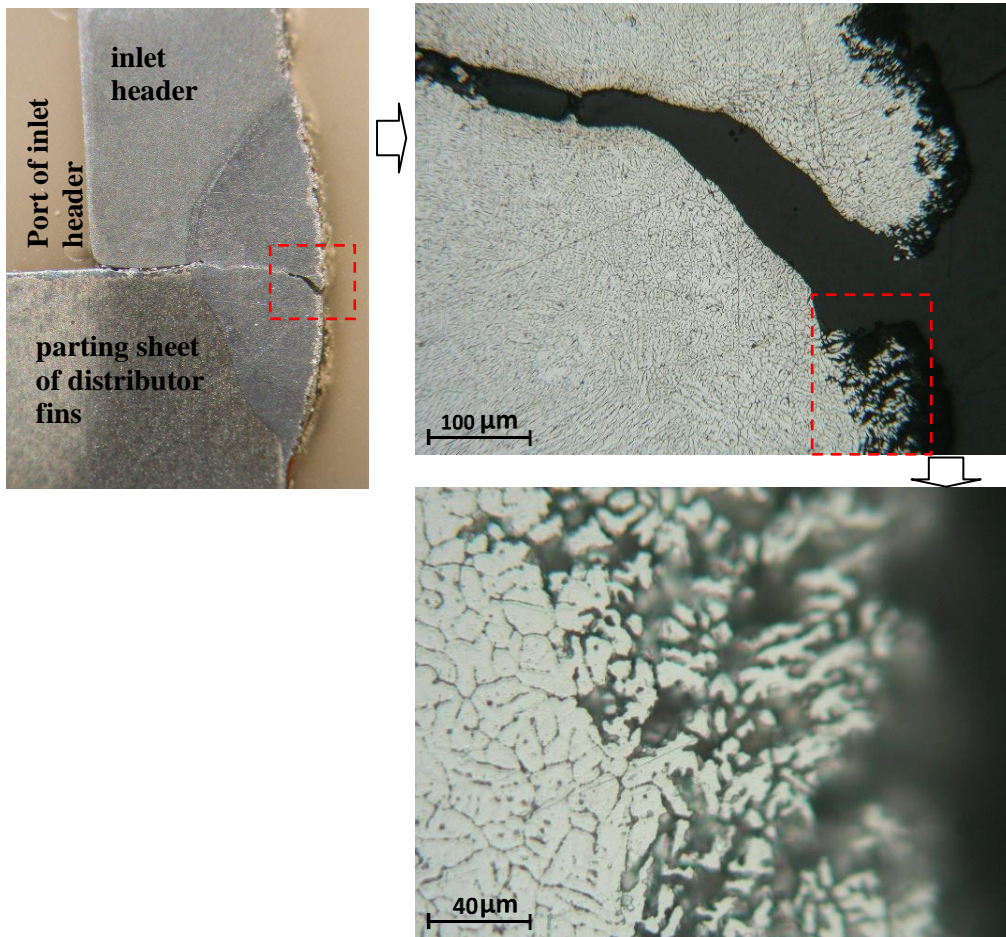
Another specimen of metallographic examination was also obtained from the leaked weld joint between the inlet header and the parting sheet of distribution fins (see Figure 8). The microstructures obtained are very much similar with that observed from the previous microstructures shown in Figure 7. The fracture shown in Figure 8 was most likely originated

from the corroded weld surface that was heavily damaged by interdendritic corrosion, and progressed into the internal port of the inlet header through the parting line between the header and the parting sheet of distributor fins. Similarly, the extended crack or fracture occurred was most also likely influenced by some weld defect (porosities) that formed in the weld joint between header and the parting sheet.

Figure 8. Microstructure obtained from the weld joint between header and parting sheet of distributor fins at location as indicated (etched with Keller solution)

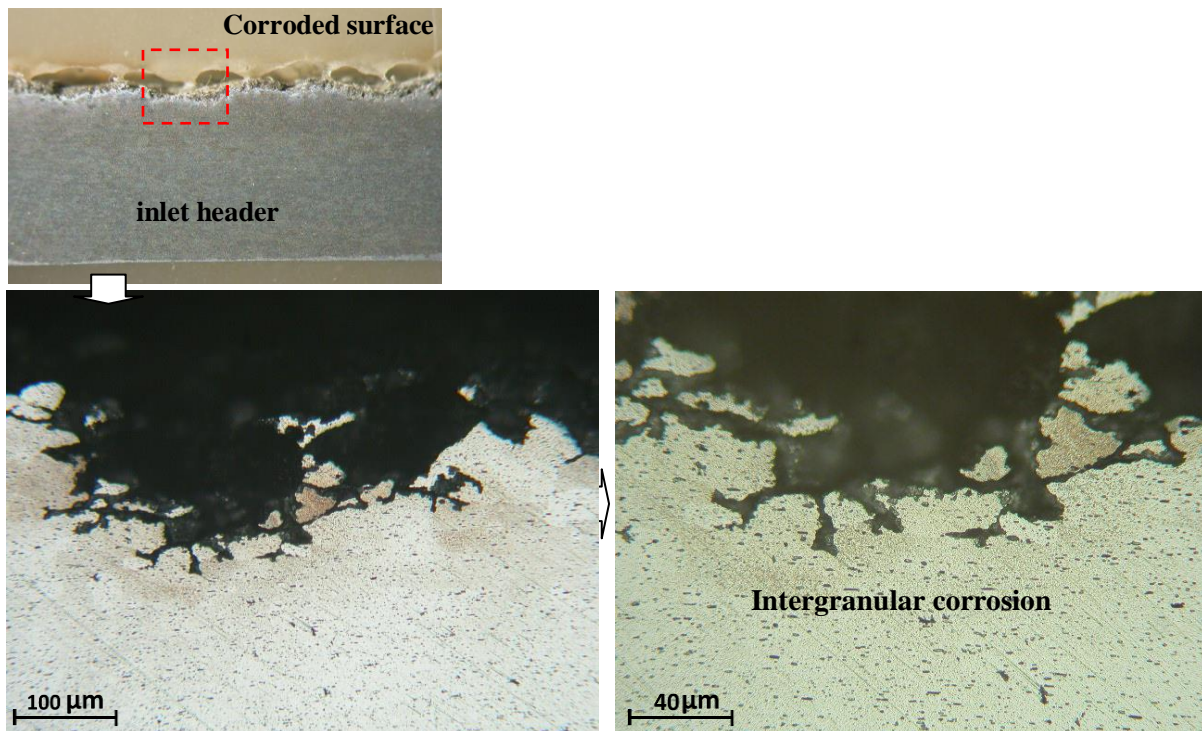
Details of the microstructure obtained from the corroded surface area of the inlet header are depicted in Figure 9. It is seen that most of the header surface was severely affected by intergranular corrosion. Similarly to the microstructures shown in Figures 7 and 8, this intergranular corrosion was most likely caused by sensitization due to formation of some intermetallic phases at the grain boundaries [1, 2, 8, 10].

Figure 9. Microstructure obtained from the corroded area of the header surface at location as indicated (etched with Keller solution)

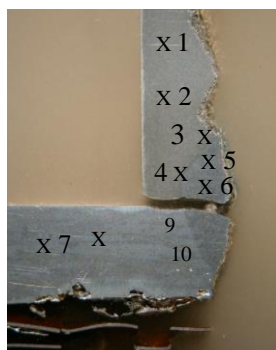
Figure 10. Various test locations for hardness survey

The hardness test was performed on the same metallographic specimen at different test locations (see Table 1). The results obtained show that the header base metal has hardness values in the range of 87.4-102 HV, i.e, slightly lower than its HAZ which is in the range of 94.6-105 HV. The hardness values of the weld metal are around 64.4 to 84.1 HV. Furthermore, the side bar or parting sheet materials have the hardness values in the range of 23.2-34.1 HV, i.e. lower than the hardness values of the side bar or parting sheet material at its respective HAZ (24.4-59.3 HV). The higher hardness values obtained from the header material compared to the hardness values of the side bar/parting sheet material indicated that both materials are made from different aluminum alloys. As mentioned in the ALPEMA standard [11,12], the header material is usually made of an aluminum alloy AA5083 type, whereas the side bar/parting sheet material is usually made of an aluminum alloy AA3003 type. Both of these aluminum alloys belong to the non-heat treatable alloys [5].

Test Location	Hardness (HV)
1	87.4
2	102.0
3	94.6
4	105.0
5	64.4
6	84.1
7	23.2
8	34.1
9	24.4
10	59.3

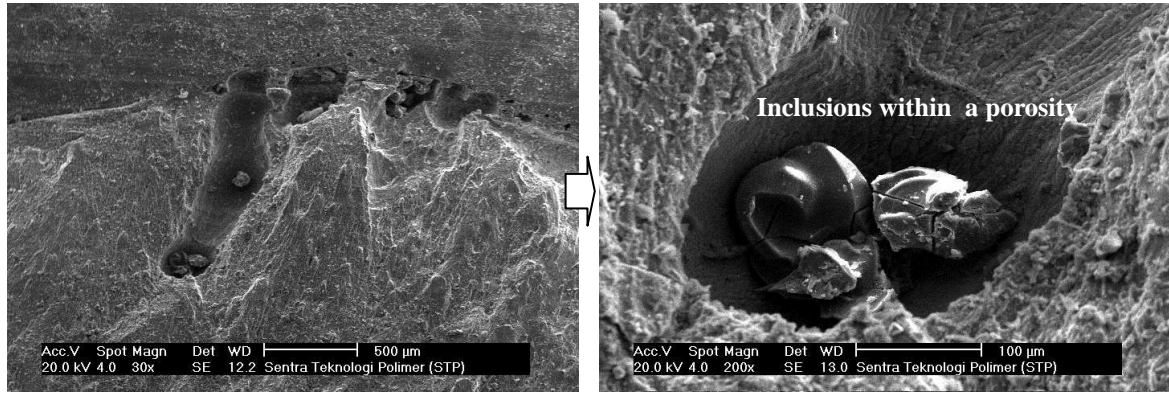
SEM fractographs obtained from fracture surface of the leaked after-cooler are presented in Figure 11. The fractographs obtained show the fracture surface of the weld joint between the header and the side bar/parting sheet that apparently contained a number of porosities. These porosities in some extent may have contributed to the crack or fracture formation. The crack seemed to initiate from the corroded surface of the weld joint and propagated into the weld defect (porosity) where the crack may have come to stop. However, the crack may have further continued to the nearest parting line between header and the side bar to complete the crack path. As seen clearly in Figure 11, a large porosity appears to fill with some inclusions.

Figure 11. SEM microfractograph of the through fracture surface obtained from the leak area of the weld joint between the header and the side bar/parting sheet, showing some inclusions within the weld defect.

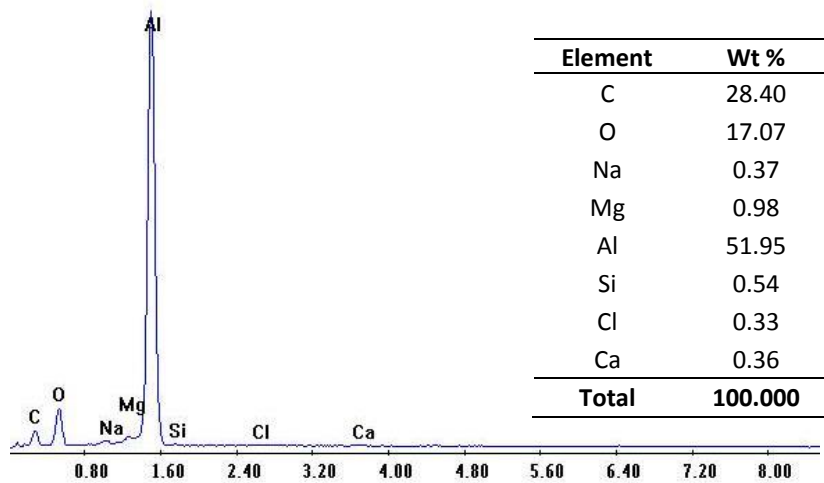
The EDS spectrum of elements obtained from the header fracture surface shown in Figure 11 that experienced corrosion damage shows some major elements such as aluminum (Al), carbon (C) and oxygen (O) (see Figure 12). The oxygen content obtained is much likely affected by the oxide formation due to corrosion (as corrosion product). Whereas the high carbon content found in the EDS spectrum may be influenced by some leakage of compressor hot lubricating oil that entered into the oil cooler. In addition to those elements, there are also other elements observed in the EDS spectrum such as magnesium (Mg), silicon (Si), sodium (Na), chloride (Cl) and calcium (Ca). Both elements of Mg and Si are the alloying elements of the aluminum alloy AA5xxx. The source of Na and Cl was most likely coming from the seawater and/or its moisture, or may be present from other aqueous environment. Figure 13 also shows the EDS spectrum of elements representing the corresponding composition of inclusion that formed inside a large porosity shown in Figure 11. The inclusion is a typical aluminum oxide that likely formed from the filler metal used during welding.

Figure 12. EDS spectrum of elements obtained from the header fracture surface shown in Figure 11.

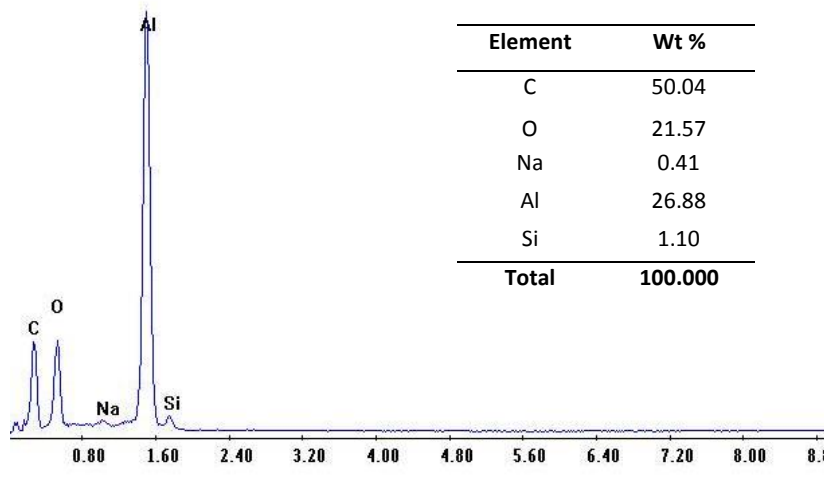
Figure 13. EDS spectrum of elements obtained from the inclusion formed in the weld defect (porosity) shown in Figure 11.

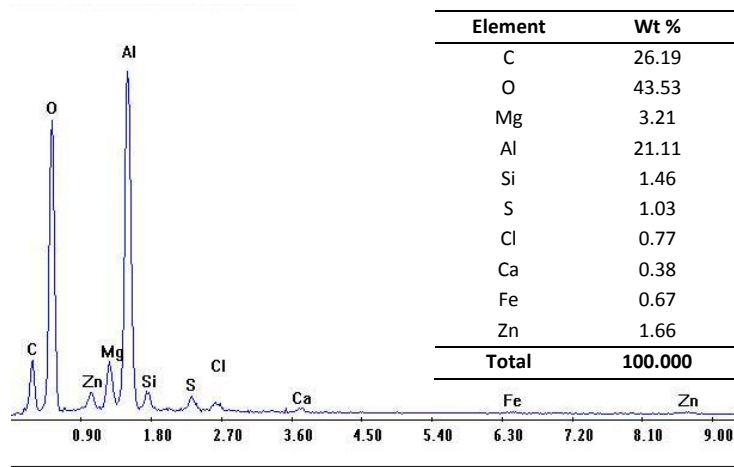
Other result of the EDS analysis obtained from the corroded surface area located around the edge of the header and the weld fracture surface is presented in Figure 14. Most of the result obtained indicated that oxygen (O) and carbon (C) along with aluminum (Al) and its alloying elements such as Si, Mg, Fe, Zn and some sulfur (S), chloride (Cl) and calcium (Ca) were detected on much of the corroded surface scale/corrosion product.

Figure 14 EDS spectrum of elements obtained from the corroded header surface shown in Figure 9.
