Technical Report

FAILURE ANALYSIS ON AN INSTRUMENT AIR COMPRESSOR AFTER-COOLER/OIL COOLER

Prof. Dr. Ir. D.N. Adnyana
Dosen Program Studi Teknik Mesin, FTI-ISTN

Jakarta, December 2020

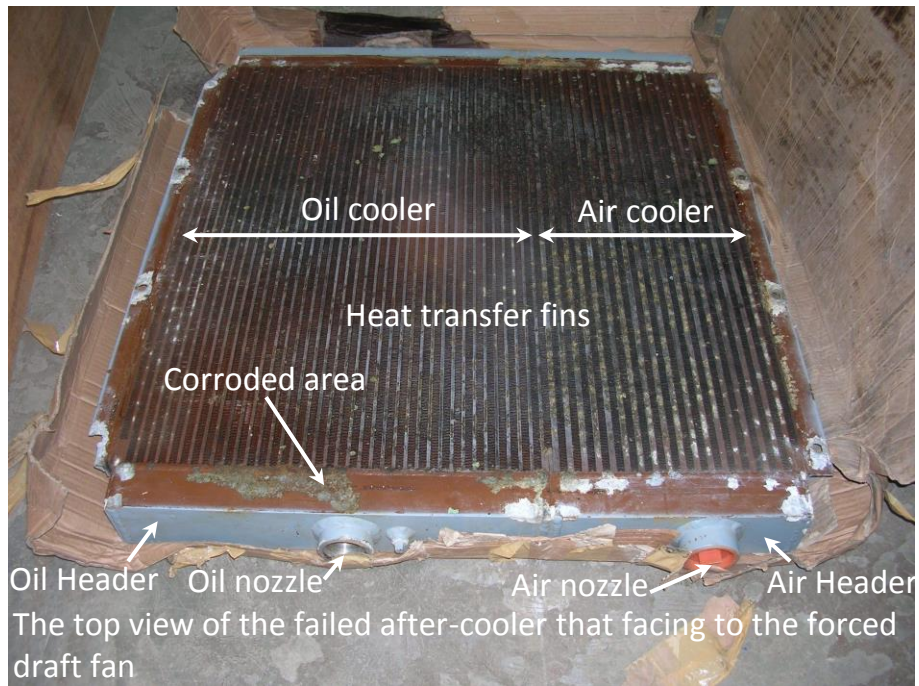
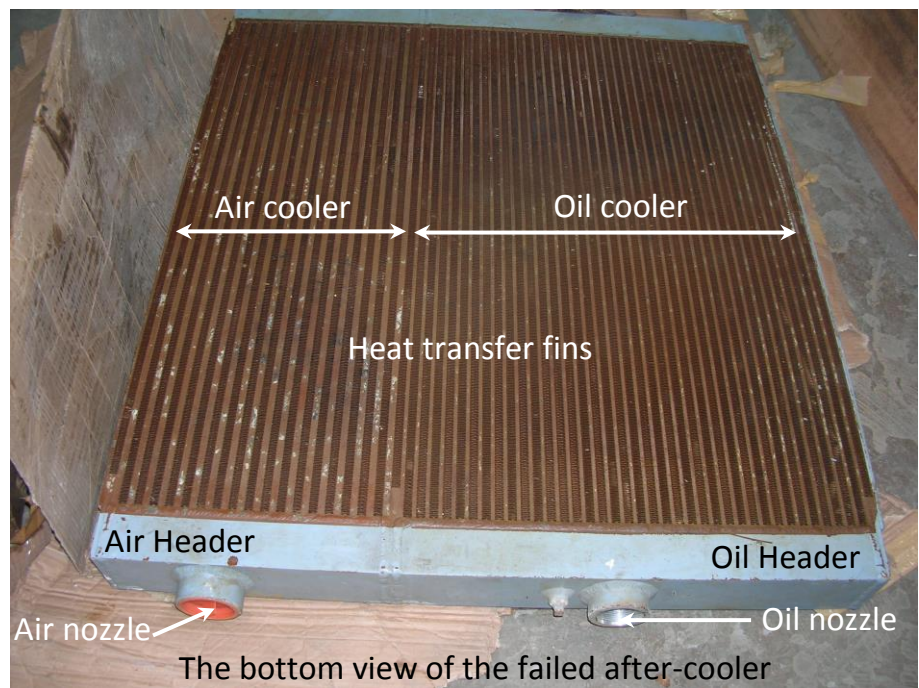
This technical report presents a failure investigation and analysis on a failed air compressor after-cooler/ oil cooler. The failed air compressor after-cooler/oil cooler used as an object in this investigation is shown in Fig. 1. From Fig. 1, it can be seen that the after-cooler is equipped with two separated or independent pressure chambers, namely air cooler and oil cooler. According to the plant report, this after-cooler was found to be leaking after several years in operation. The specification of this after-cooler was written on a nameplate or tag which give the following information:

Fig.1. The as received air/oil compressor after-cooler for failure analysis

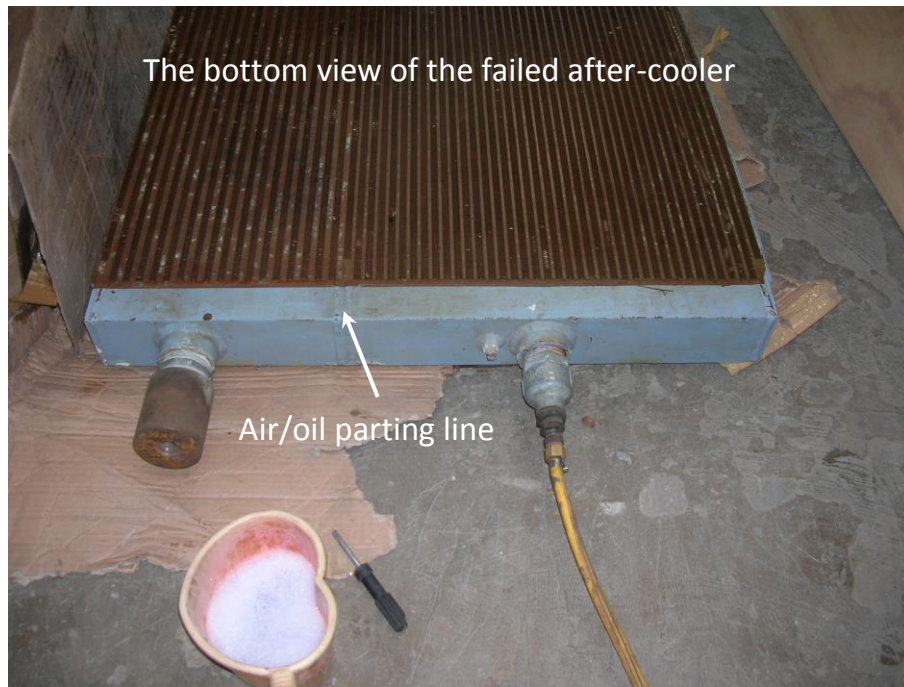
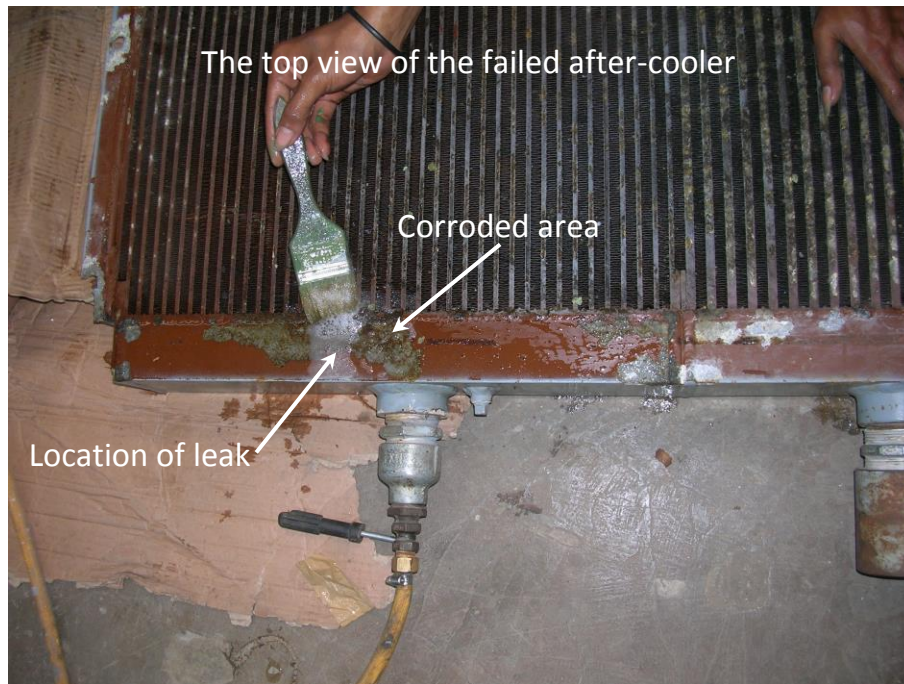
As seen in Fig. 2, a leak test was carried out on the failed after-cooler using compressed air to find the location of leak. From the test, it was found that the leak was located at some area as indicated in Fig. 2, namely on some possibly corroded area. From Fig. 2, it can also be seen that the leak was situated on the oil cooler at the weld joint between the header and the side bars/parting sheets across the port. The leak was approximately 3 - 5 cm length and formed along the parting line of the weld joint.

Fig.2. Leak test on the failed after-cooler using compressed air to find the location of leak

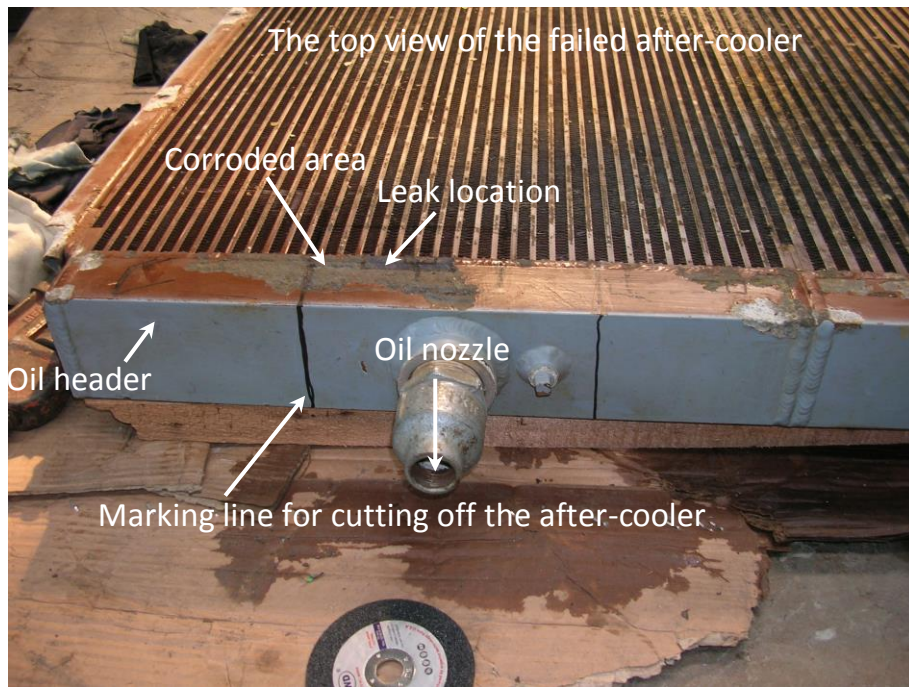
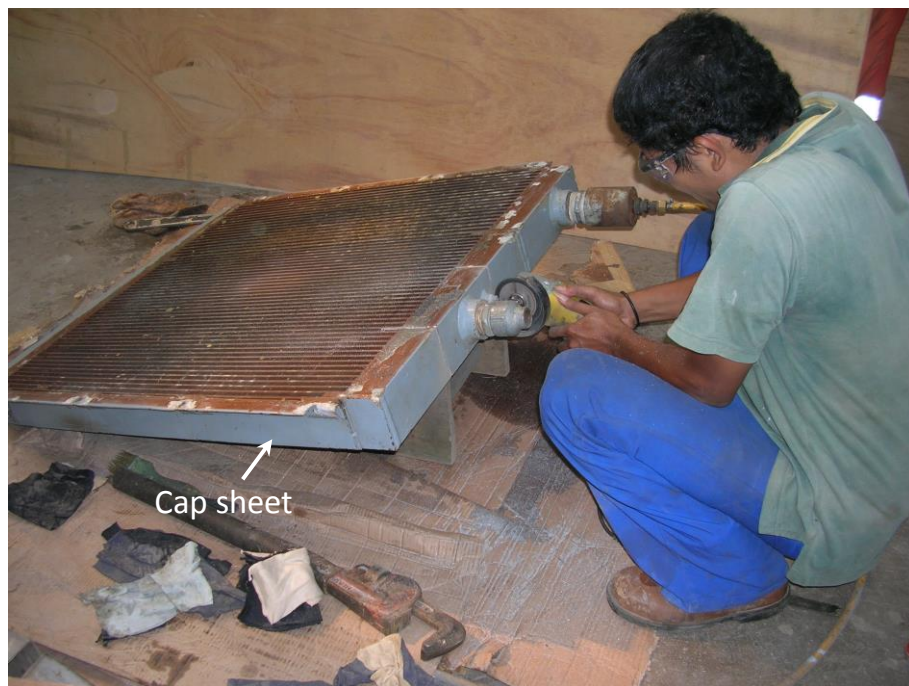
Fig.3. Cutting off the failed after-cooler around the leak location for sample preparation

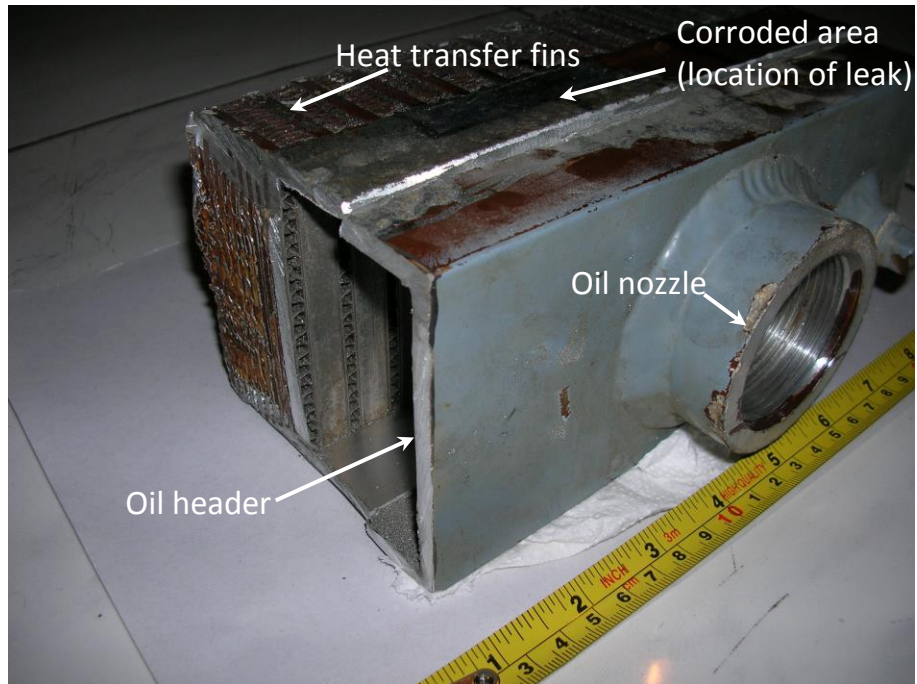
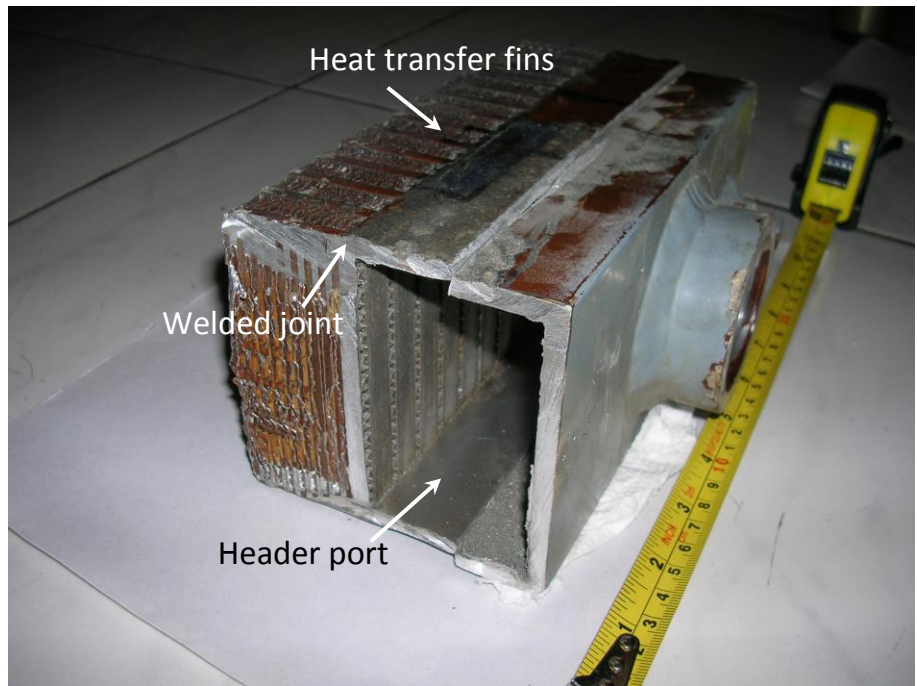
Fig.4. Section of the failed after-cooler for sample preparation

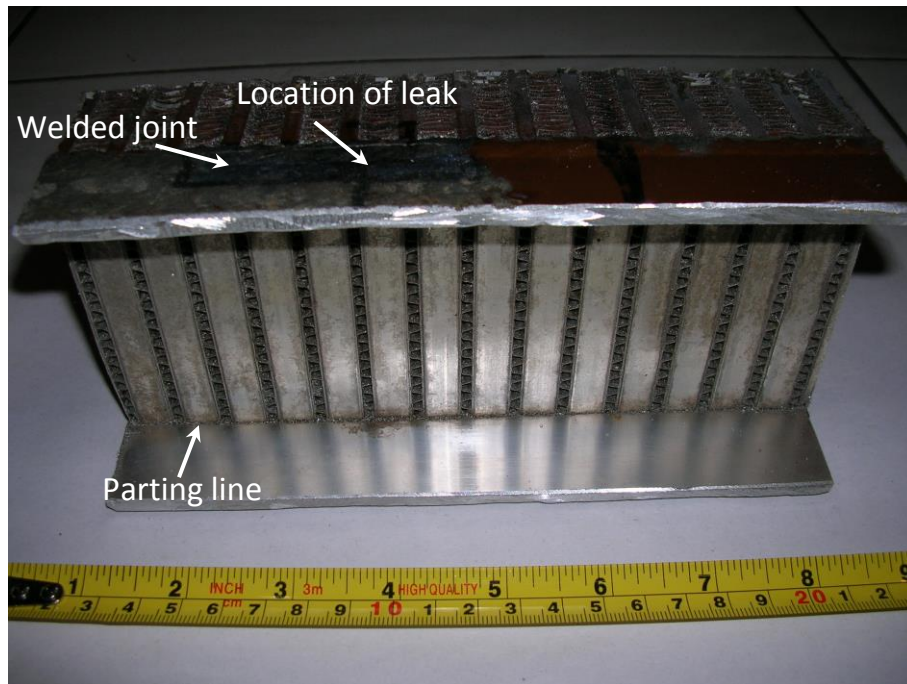
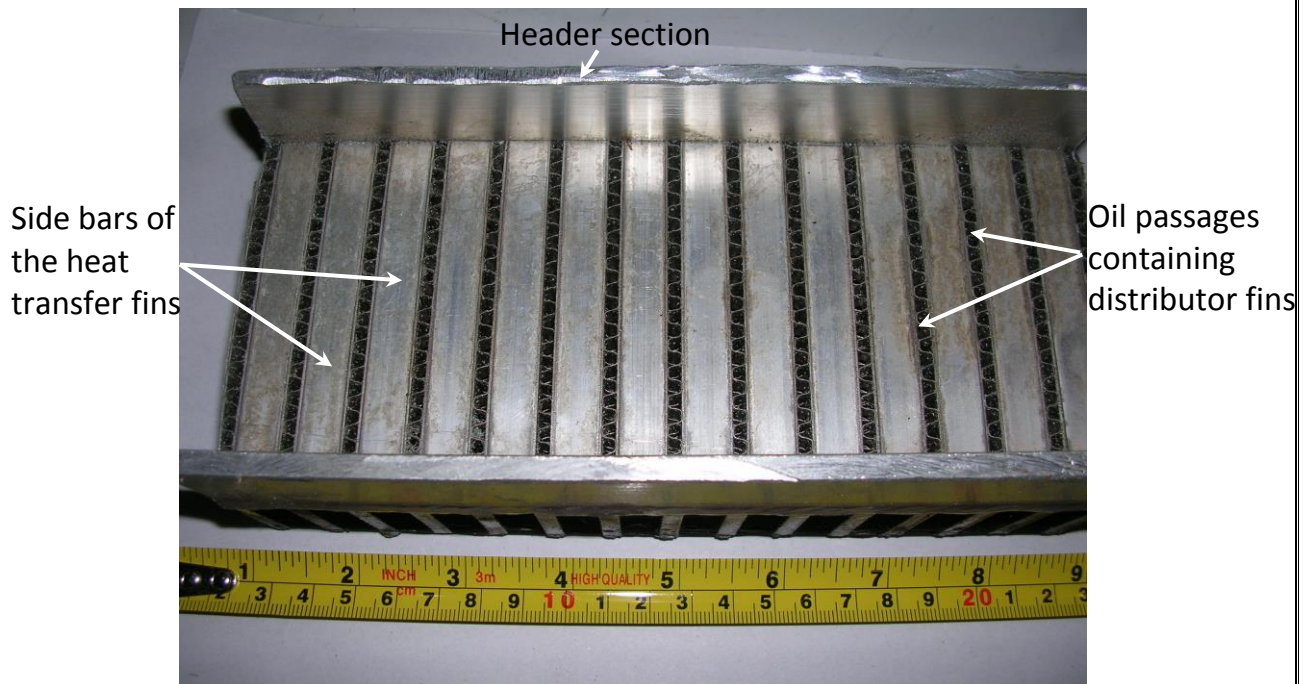
Fig.5. Close up view of the inside header port, showing a number of oil passages containing distributor fins and parting line of the weld joint between header and side bars/parting sheets.

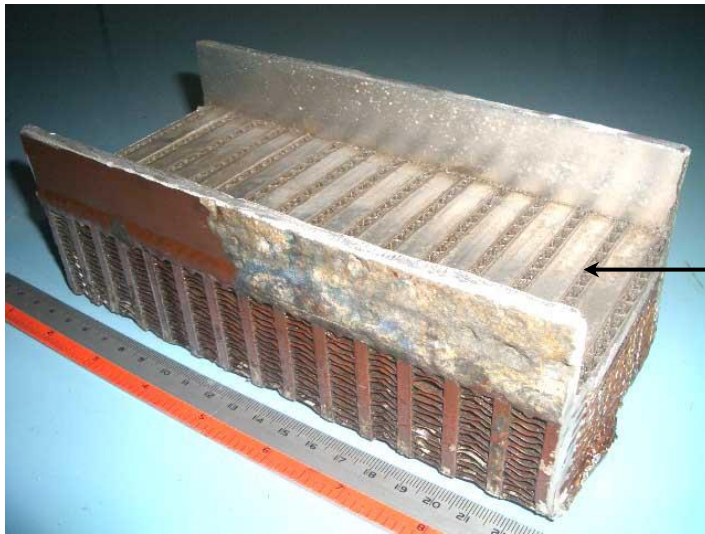
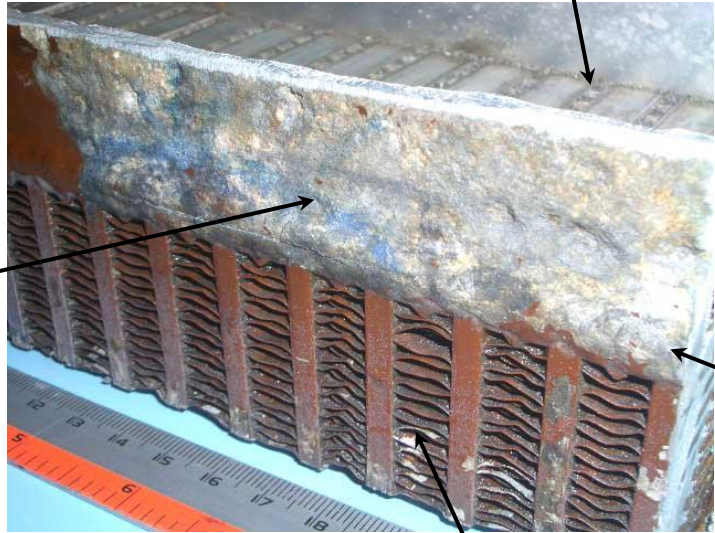
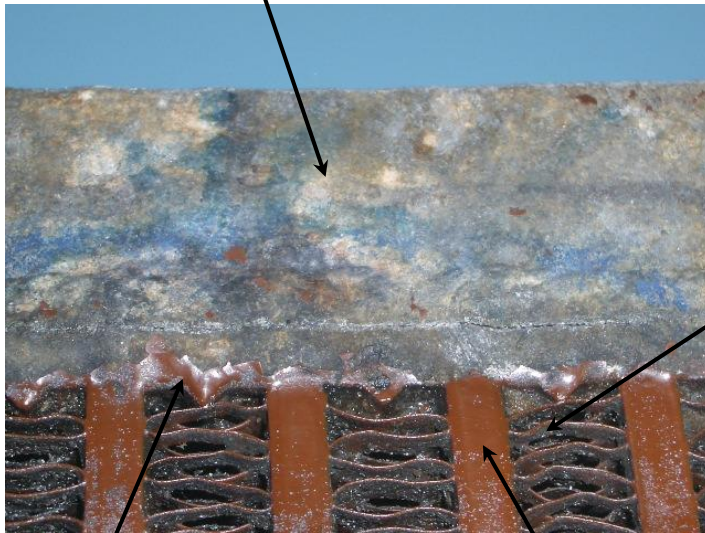
A close up view of the failed after-cooler around the leak location is given in Figs. 6 and 7. From Figs. 6 and 7, it is clearly seen that the oil leak from the after-cooler was most likely escaped out of the after-cooler through a linear crack that formed on the parting line of weld joint between the header and the side bars/parting sheets. It is also seen in Figs 6 and 7 that the crack line was formed on the corroded area of the header/weld joint surface (see also Fig. 8).

Corroded area

Fig.6. External corrosion on some area of header surface and the weld joint

- The source of Cl and S as contaminants that may have caused external corrosion on some particular area of the after-cooler must be fully investigated in order to avoid any similar accident in the future.
- The weld joint quality between the header and the side bars/parting sheet of the corrugated fins during after-cooler fabrication should be improved to avoid any formation of pinhole (gas porosity) and other welding defects. This may be obtained by improving the application of welding process parameters such as:

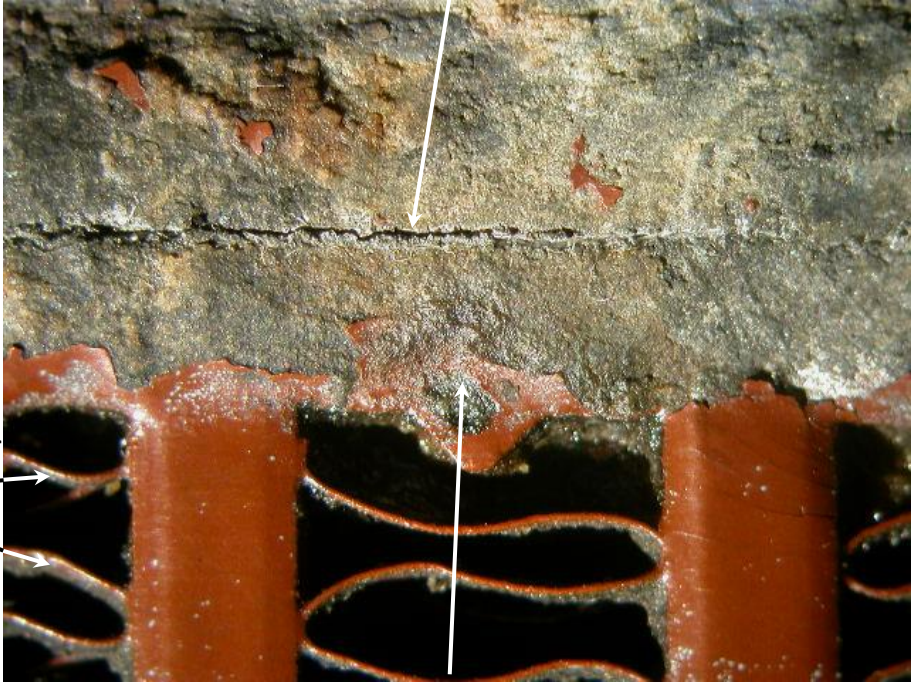
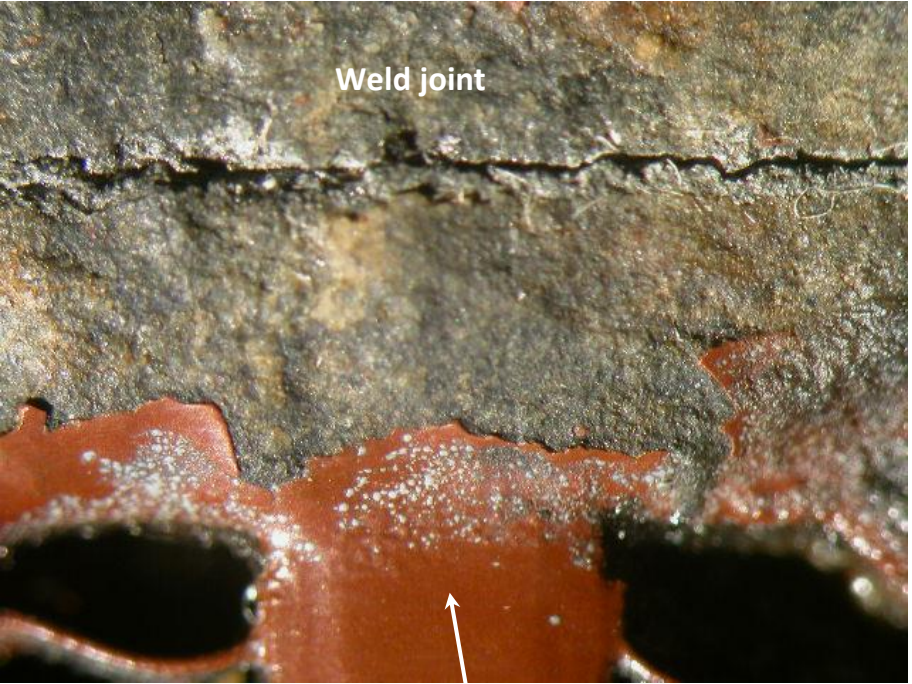
Crack on the parting joint line between the header and the side bars/parting sheets

Fig.7. Close up view of the corroded surface area as seen in Fig. 6

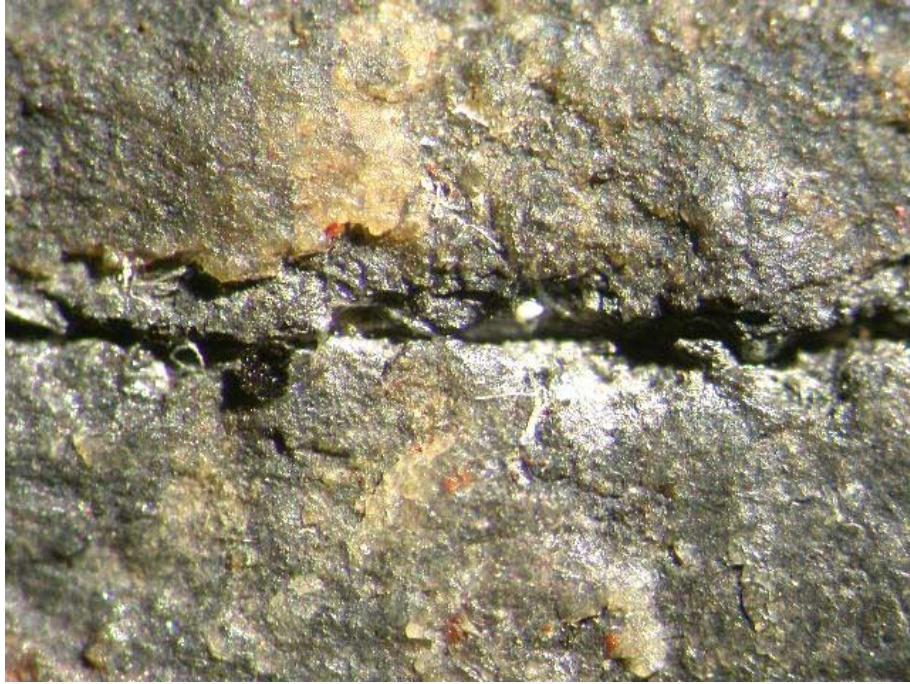
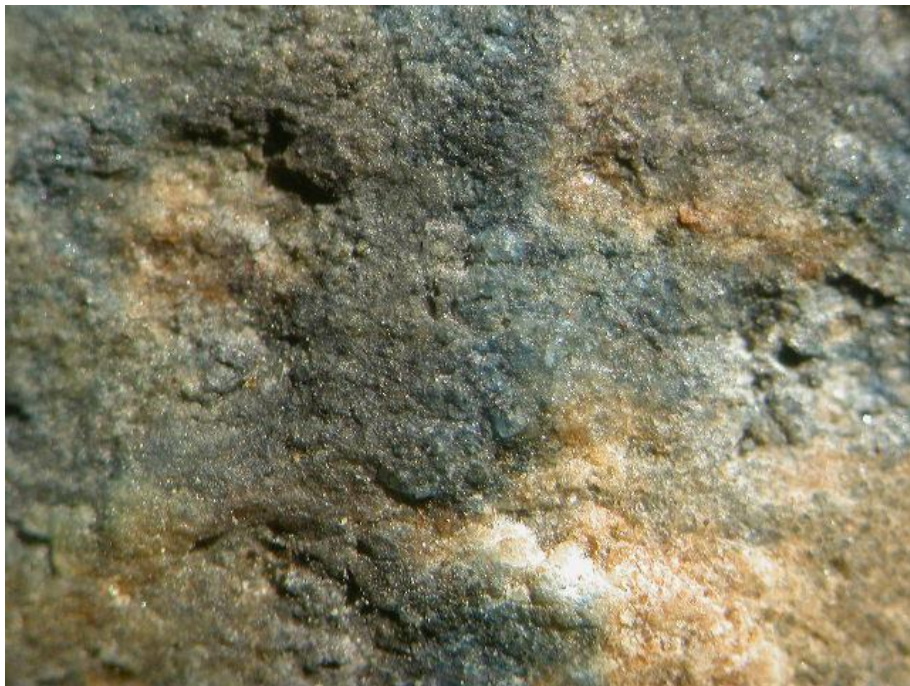
Fig.8. Close up view of the corroded surface area as seen in Fig. 7

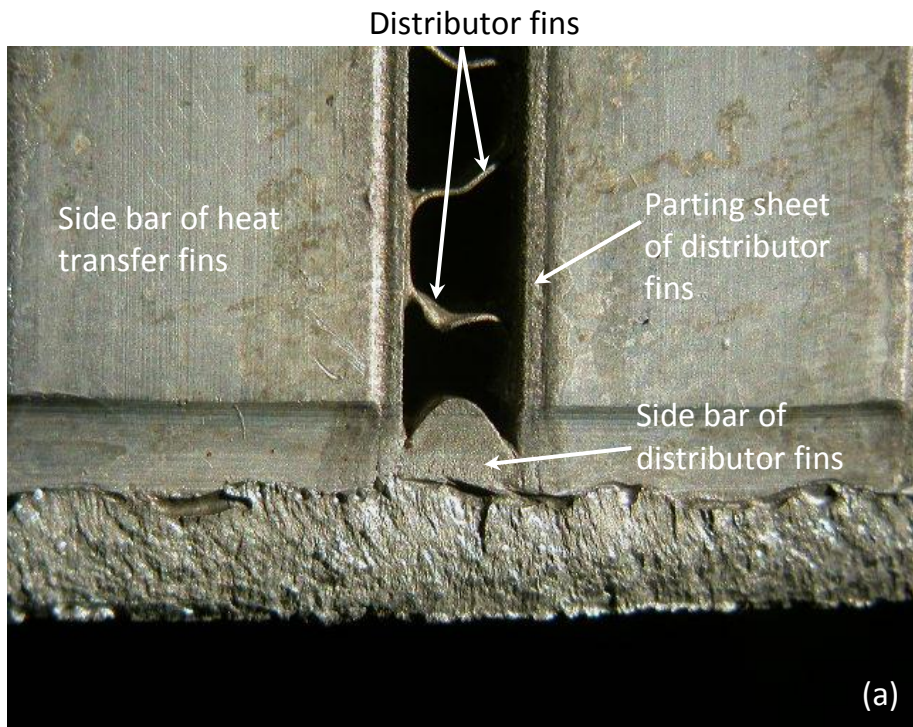
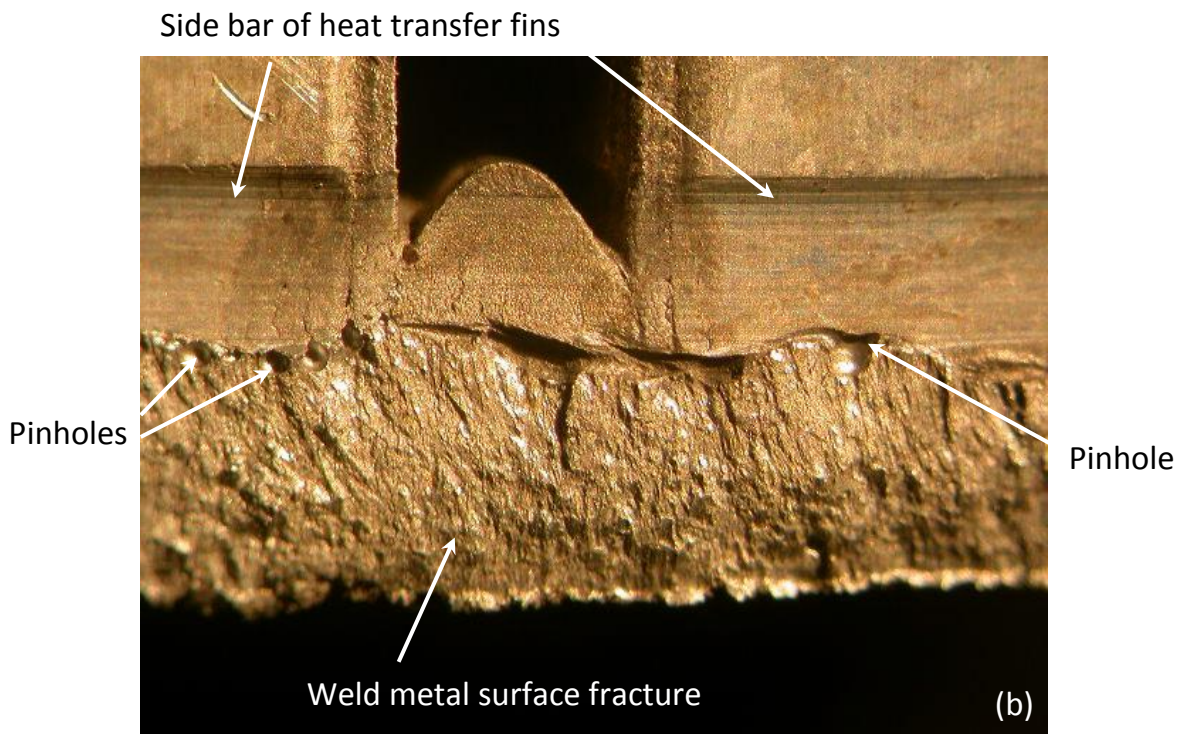
Some specimens for macroscopic examination were prepared from the sectioned part of the failed after-cooler. The photomicrographs were obtained using a stereo microscope at various magnifications. The results of macroscopic examination obtained from some leaked area on the weld joint between the header and the side bars/parting sheets are presented in Figs. 9 and 10. It is clearly seen that most of the weld surface fracture apparently contained a number of pinholes due to gas porosity. Most of the pinholes were formed on the

parting line between the weld and the side bars/parting sheets. Furthermore, some corrosion attack was also indicated to have entered into some surface fracture of the weld (see also Figs. 6 to 8).

Fig.9. Surface fracture of the weld joint between the header and the side bars/ parting sheets
 a) at lower magnification
 b) at higher magnification

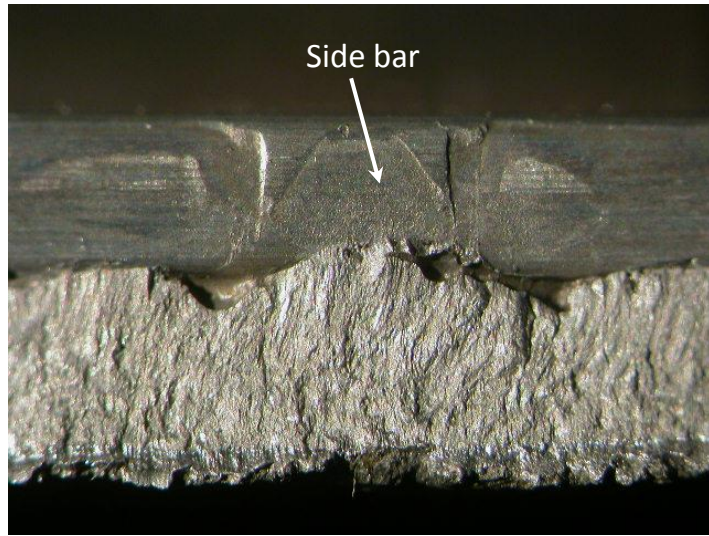
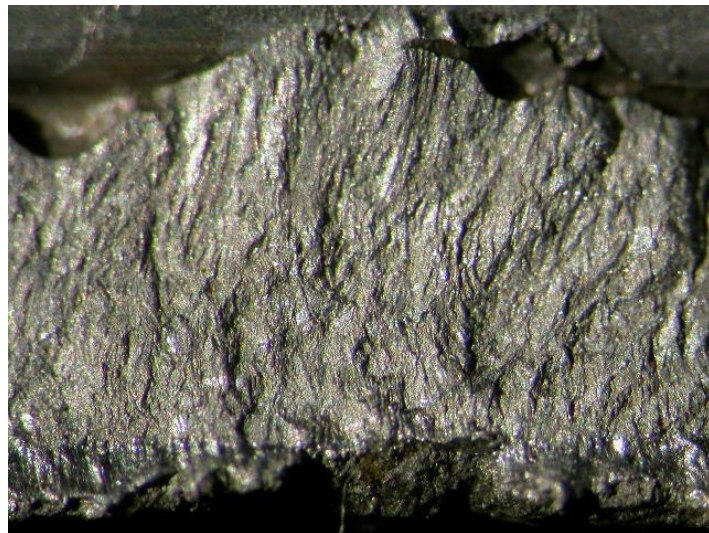
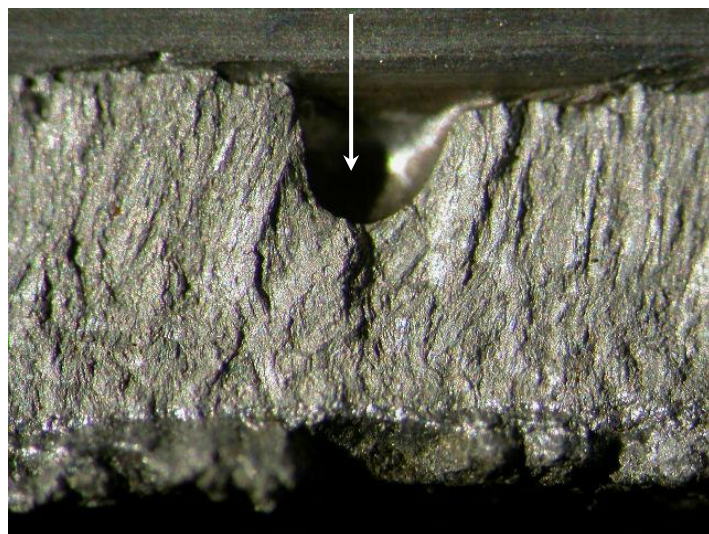
Weld defect (gas porosity)

Fig.10. Surface fracture as seen in Fig. 9 but at higher magnification

by proper selection of welding electrode (filler metal), welding current and speed.

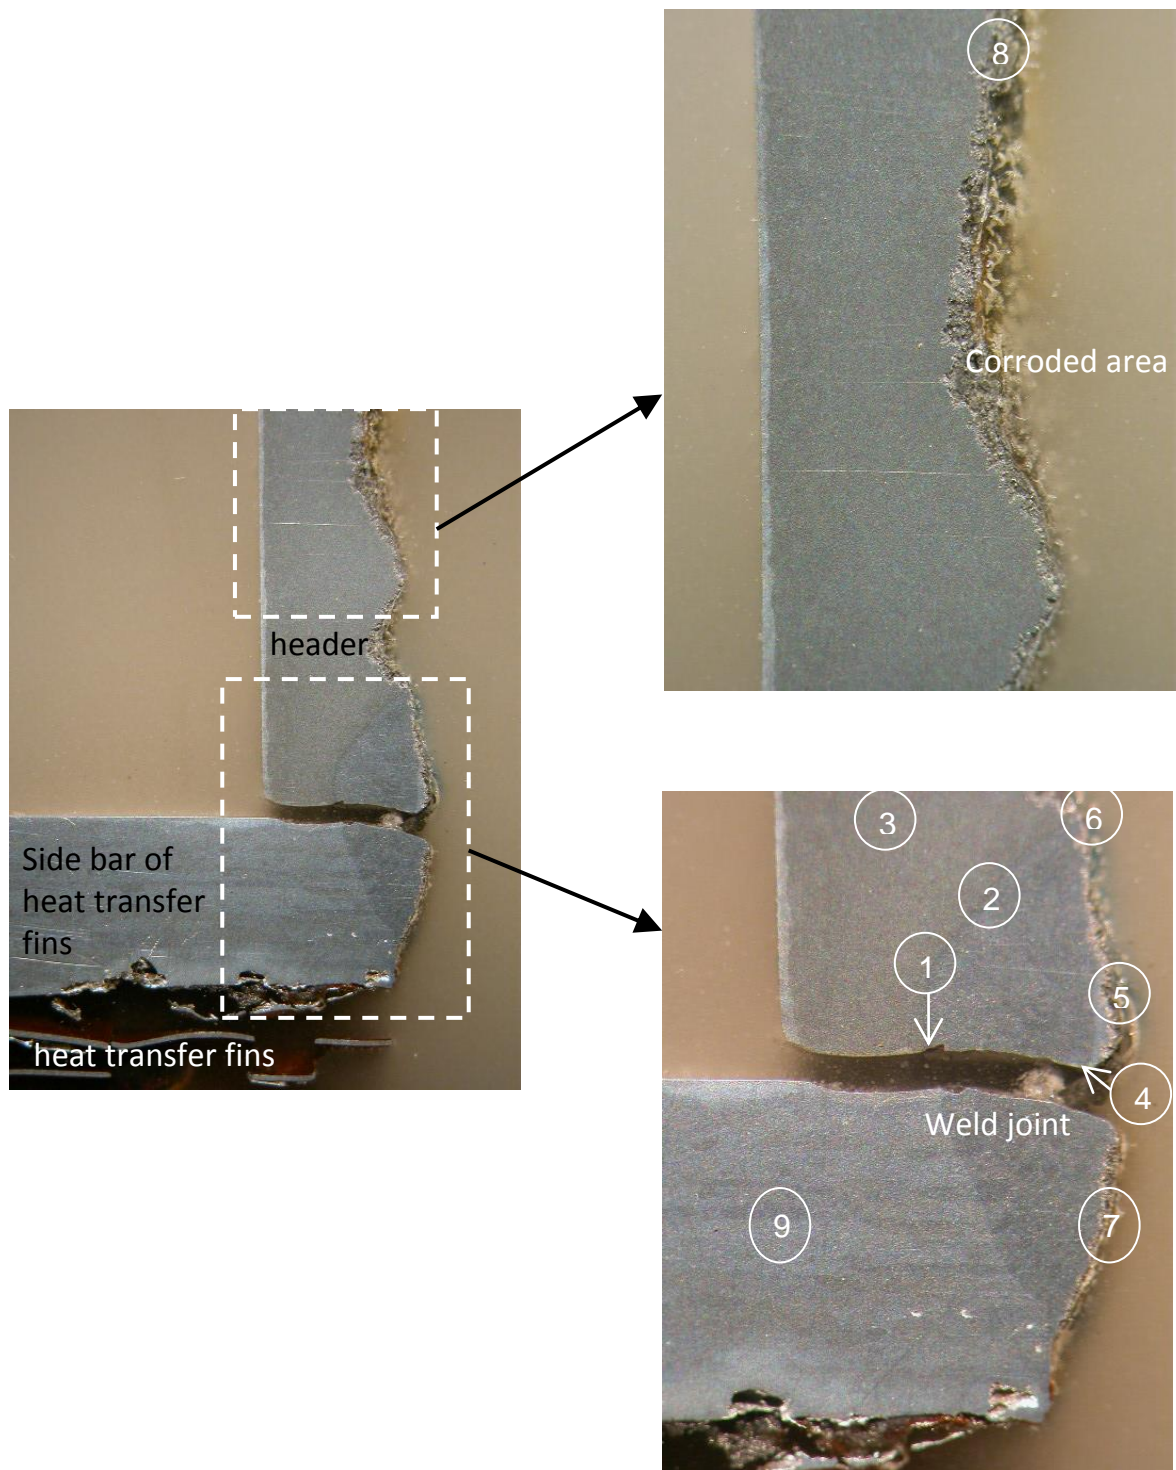
Figure 11 shows a cross section of a polished and etched specimen obtained from the leaked weld joint between the header and the side bar. The specimen shows a fracture line lied along the parting line between the header and the side bar of heat transfer fins. The fracture may have been originated from the heavily corroded weld surface. Microstructures obtained from the specimen as seen in Fig. 11 are presented in Fig. 12 at different locations. Location 1 in Fig. 12 shows some pinholes formed in the weld joint that may have contributed to the fracture. Locations 2 and 3 in Fig. 12 exhibit some microstructures of weld metal, heat affected zone (HAZ) and base metal of the header material.

Fig.11. Cross section of a polished and etched specimen obtained from the leaked weld joint between the header and the side bars/parting sheets (sample 1)

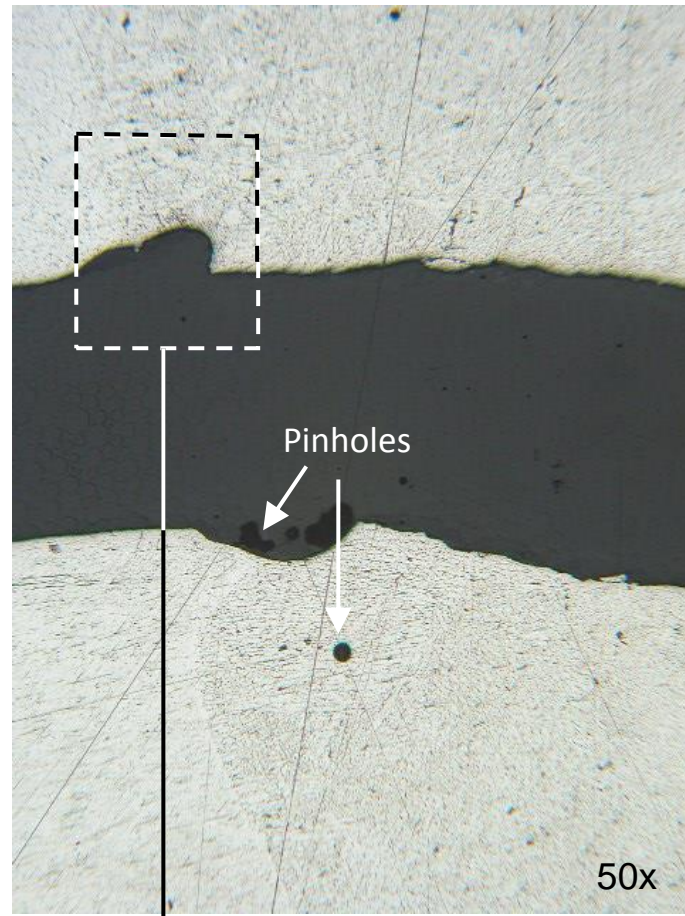
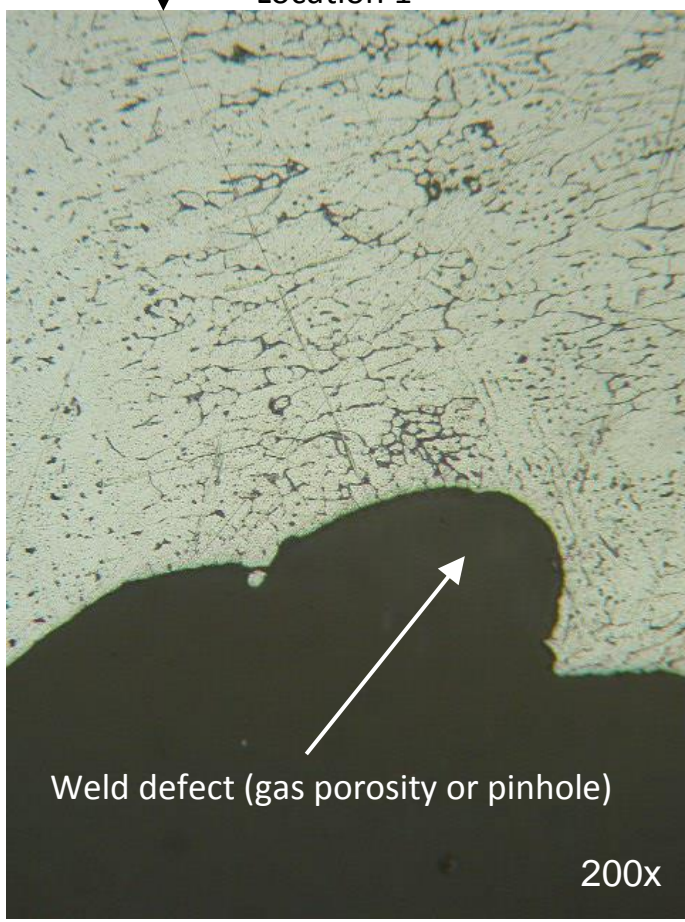
The weld metal generally shows a typical dendritic microstructure, while the microstructure of the header material shows typical wrought aluminum alloy 5000 series containing fine second phase particles. While the microstructures obtained from locations 4 to 8 in Fig.12 show some heavily damaged area due to some external corrosion. The corrosion attack on the weld metal surface in general shows a typical interdendritic corrosion, while on the wrought aluminum alloy of the header material the corrosion was found to be a typical intergranular corrosion.

Weld defect (gas porosity or pinhole)

Fig.12. Microstructures obtained from location 1 of Fig. 11

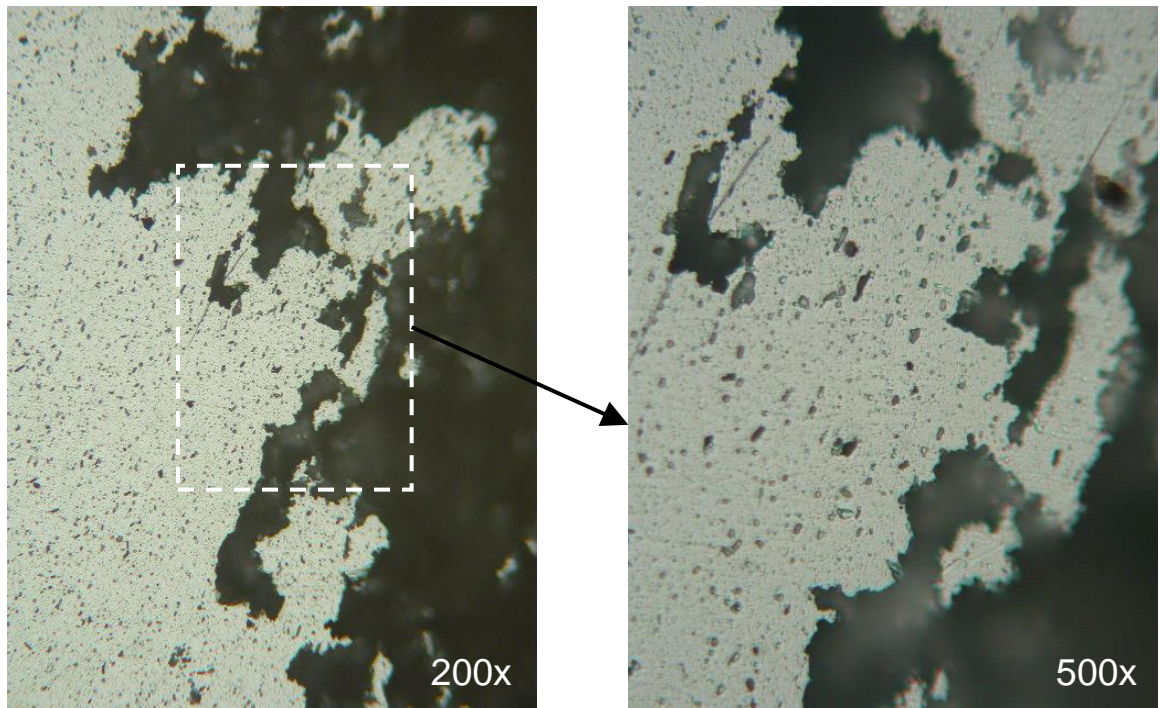
Fig.12. Microstructures obtained from location 8 of Fig. 11, showing heavily corroded area on some header surface (continued)

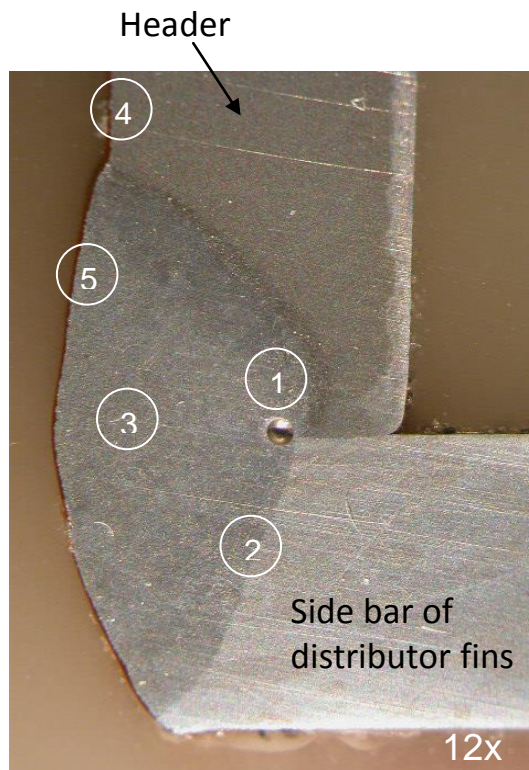
Sample 3 as seen in Fig.15 shows cross section of a polished and etched specimen obtained from some area outside the leaked weld joint between the header and the side bar of distributor fins. Figure 16 shows the microstructures obtained from different locations as indicated in Fig.15. Location 1 in Fig.16 shows a large pinhole formed in the weld metal just around the end of the parting line that was formed between the header and side bar of distributor fins. Since there was no any significant corrosion taking place on the weld surface, in the presence of this large pinhole it did not likely produce any fracture along the parting line. Locations 2 to 5 of sample 3 in Fig.16 show similar microstructures as obtained from samples 1 and 2 in which the weld metal has a typical dendritic microstructure, while the header material exhibits a typical wrought aluminum alloy containing second phase particles. It can also be seen in Fig.16 that some slight corrosion has been taking place on locations 4 and 5, but this corrosion did not likely affect to any crack formation.

Fig.15. Cross section of a polished and etched specimen obtained from the area outside the leaked weld joint between the header and the side bar of distributor fins (sample 3)

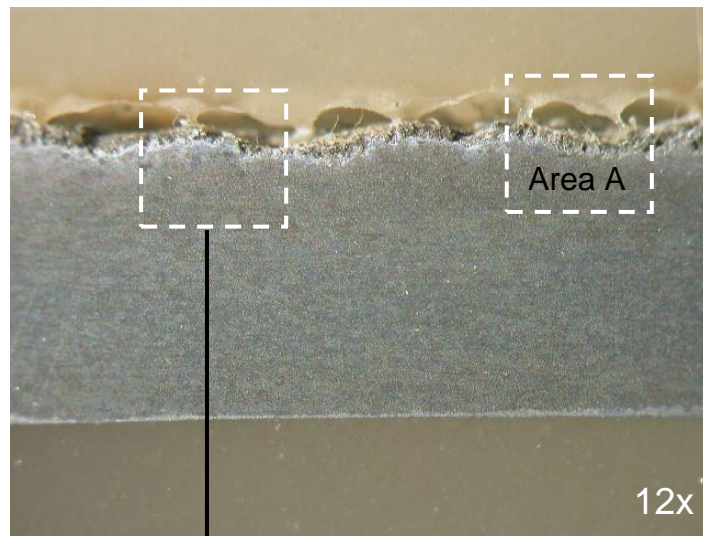
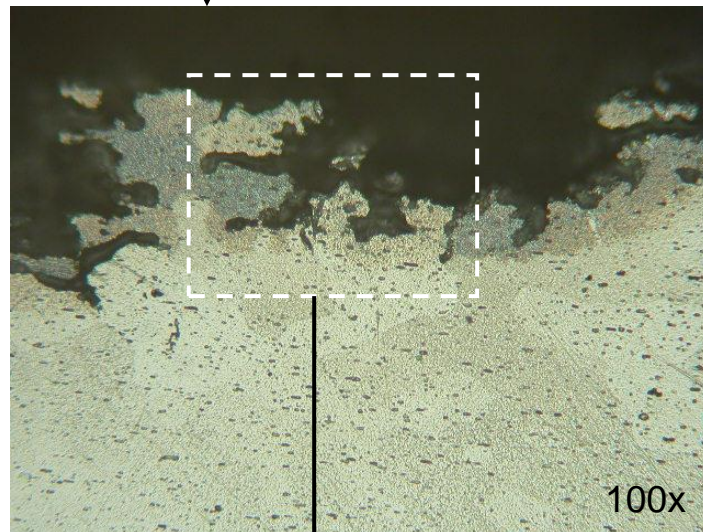
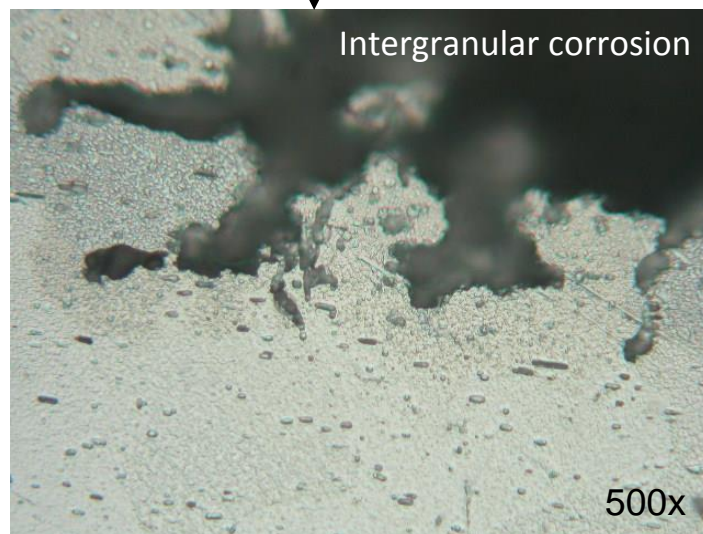
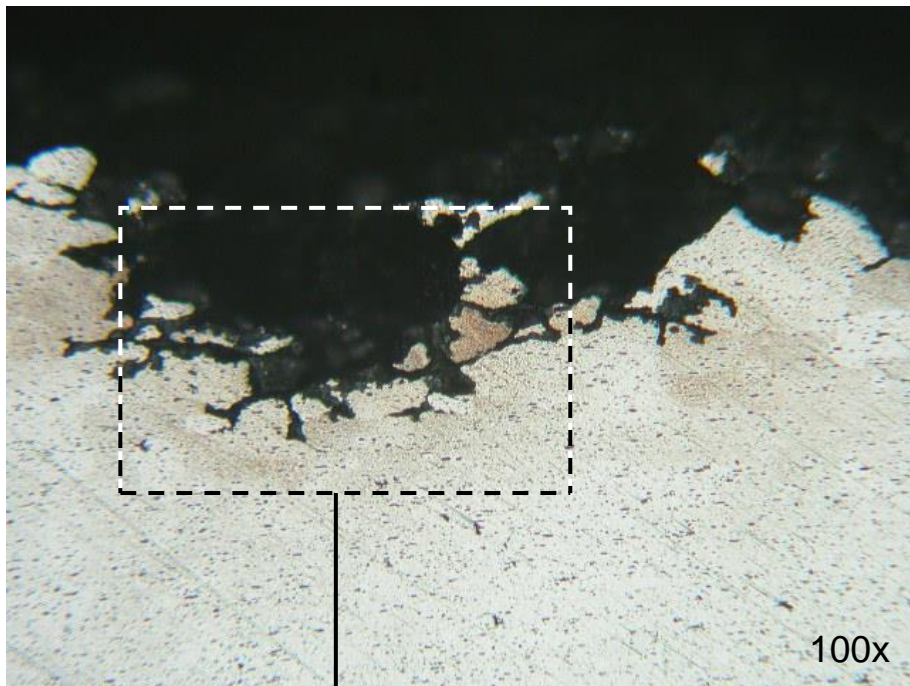
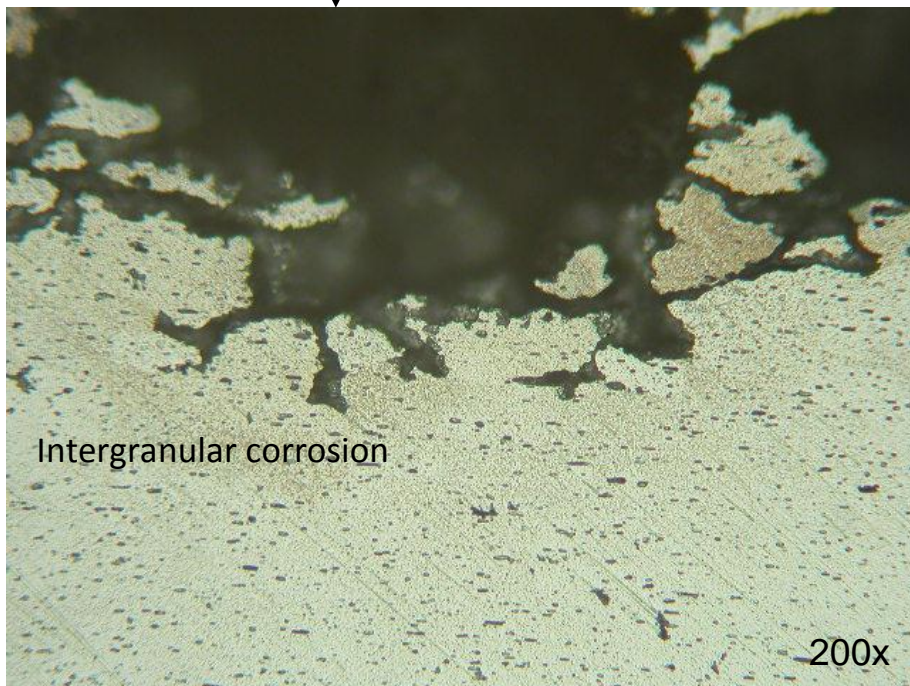
Details of microstructure obtained around the corroded surface area of the header (sample 4) are given in Fig. 17. It is clearly seen that most of the header surfaces were severely attacked by intergranular corrosion. This intergranular

corrosion has eaten away some of the header material and reduced its effective cross sectional area.

Fig.17. Cross section of a polished and etched specimen obtained from the corroded area of header surface (sample 4)
