Technical Report

FAILURE ANALYSIS ON AN INSTRUMENT AIR COMPRESSOR AFTER-COOLER/OIL COOLER

Prof. Dr. Ir. D.N. Adnyana
Dosen Program Studi Teknik Mesin, FTI-ISTN

Jakarta, December 2020

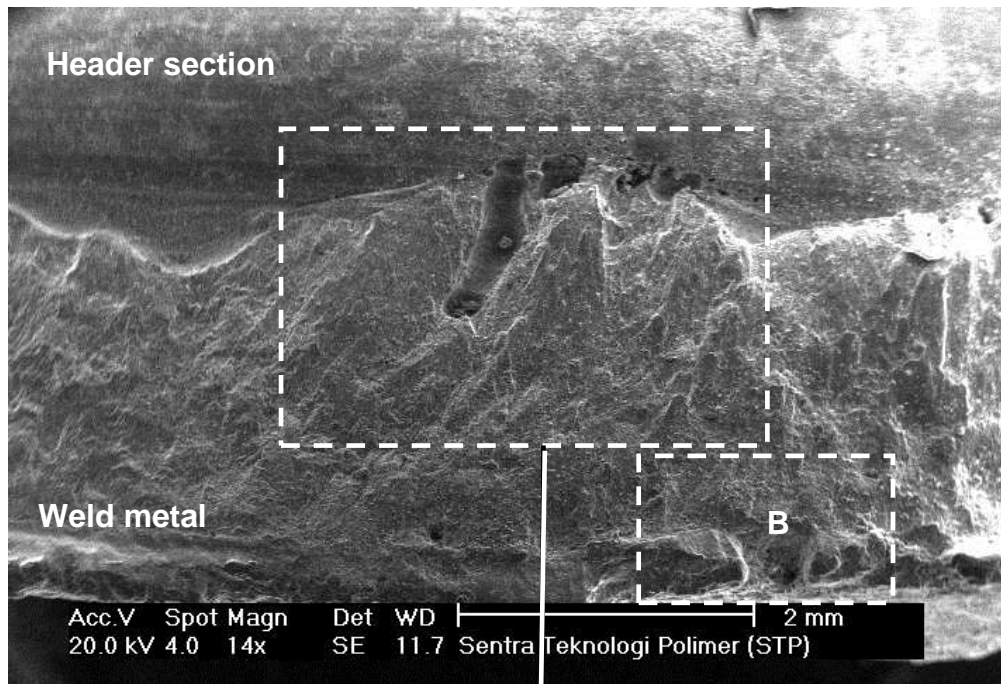
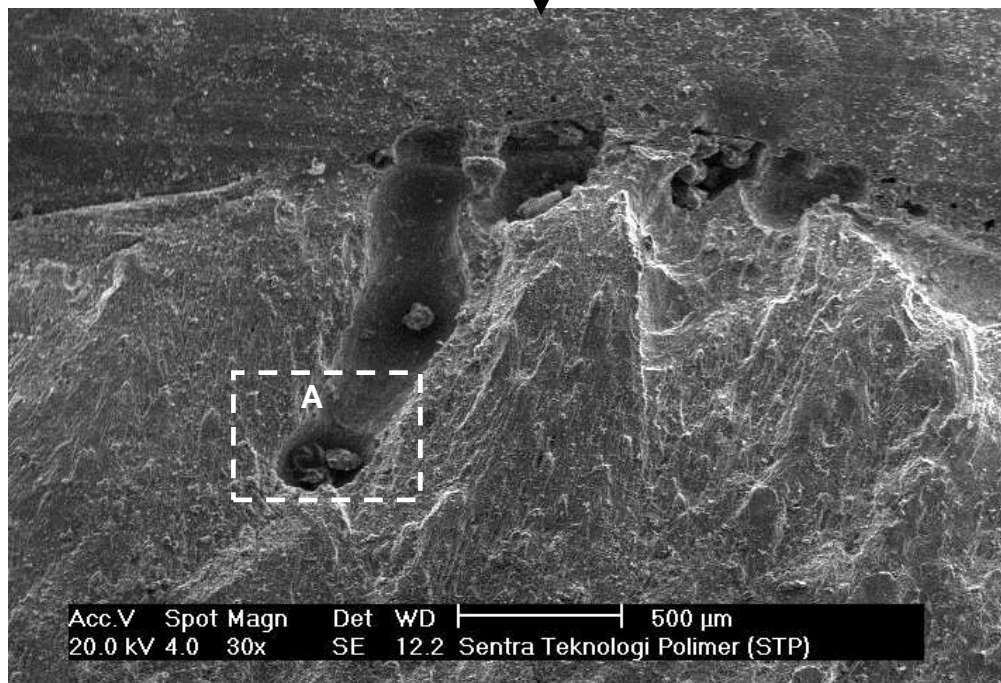
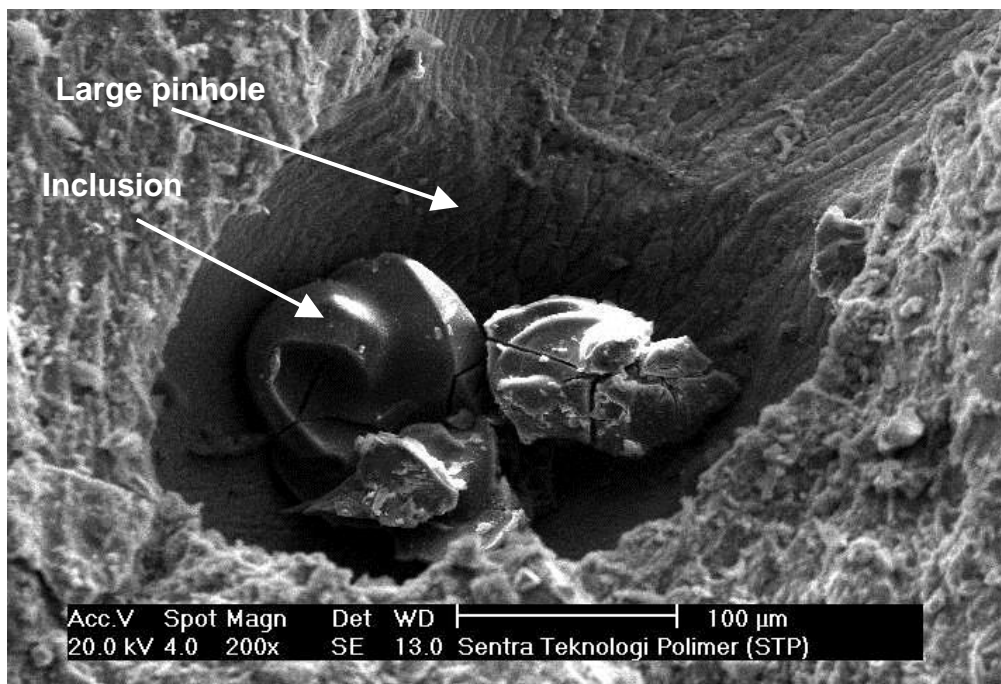
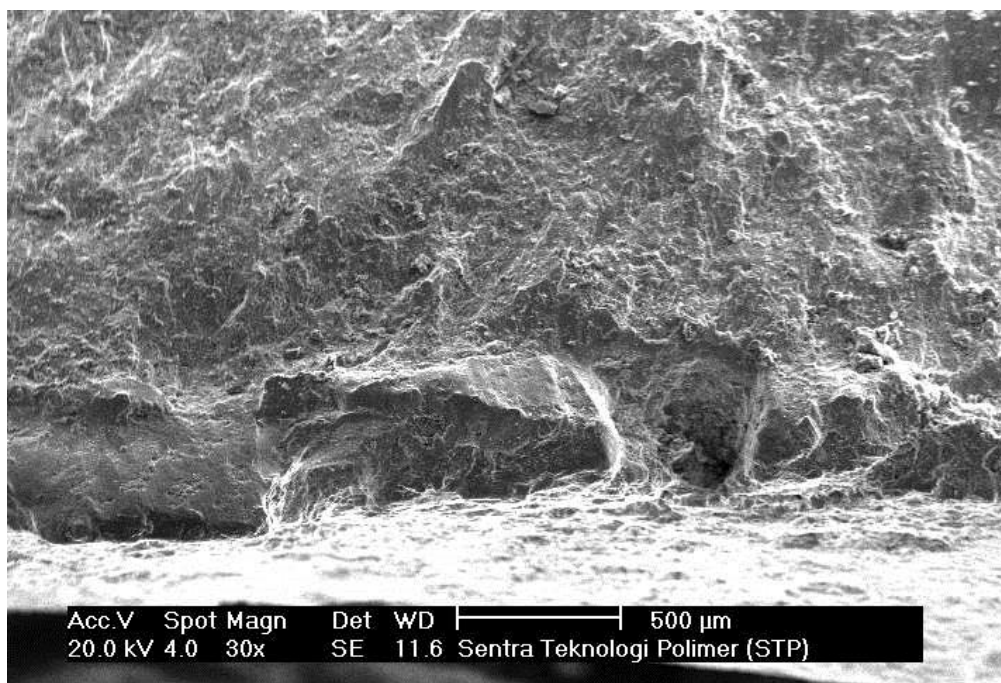
Samples for SEM fractography and EDS analysis were cut-off from some surface fracture of the failed after-cooler around the leak area. Figure 18 shows some surface fracture obtained from the leak area of the weld joint between the header and the side bar/parting sheet. It can be clearly seen from Fig. 18 that the surface fracture of the weld joint apparently contained a number of pinholes that mostly formed on the parting line between the weld and the header. These pinholes in some extent may have contributed to the crack or fracture formation. As seen in Fig. 18, some large pinholes were filled with some inclusions. As

indicated in Fig. 18, the crack may have been initiated from the corroded surface of the weld metal (see lower part of Area B in Fig. 18) and progressed inward to the area of high stress concentration that may have been caused by the pinholes.

Fig.18. SEM micrographs of some surface fracture obtained from the leak portion of the weld joint between the header and side bar/parting sheet.

- Other effort that may be required to further improve the weld joint quality is by adding some other fillet weld on the parting line inside the header port. This additional fillet weld may increase the load carrying capacity of the weld joint structure so that it may increase the operating life of the after-cooler significantly.

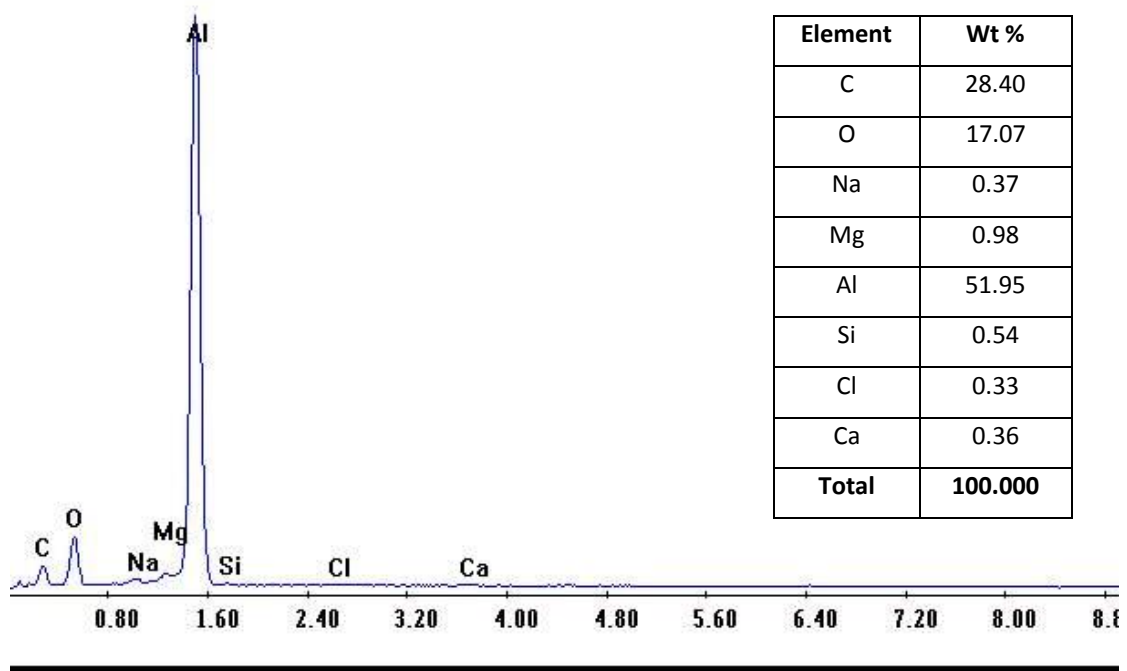
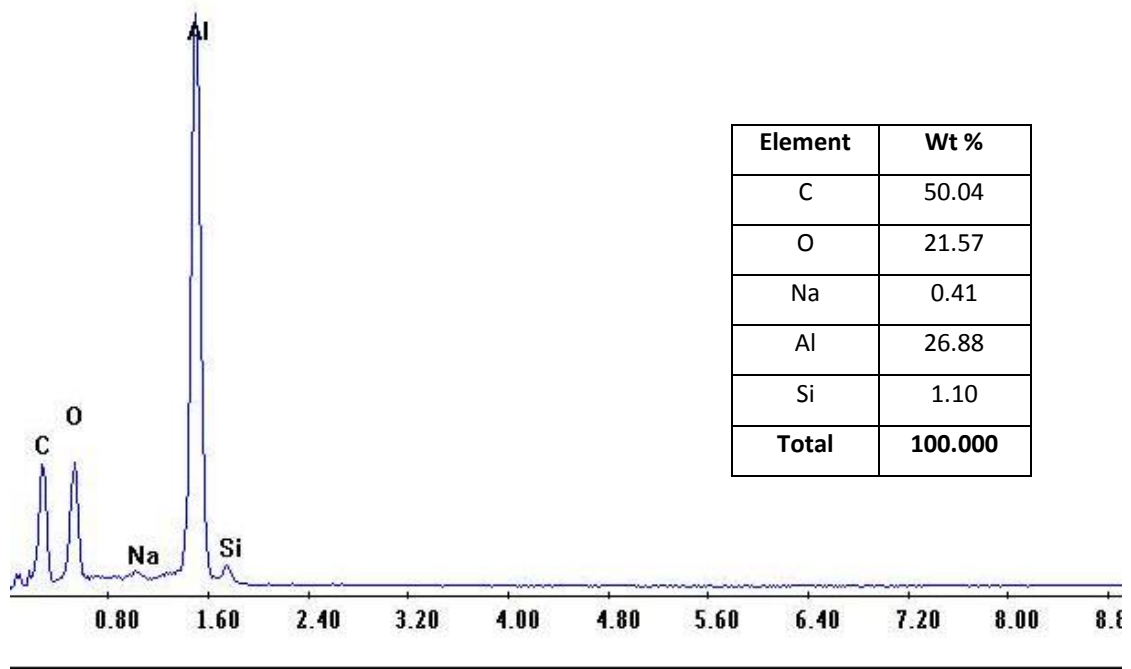
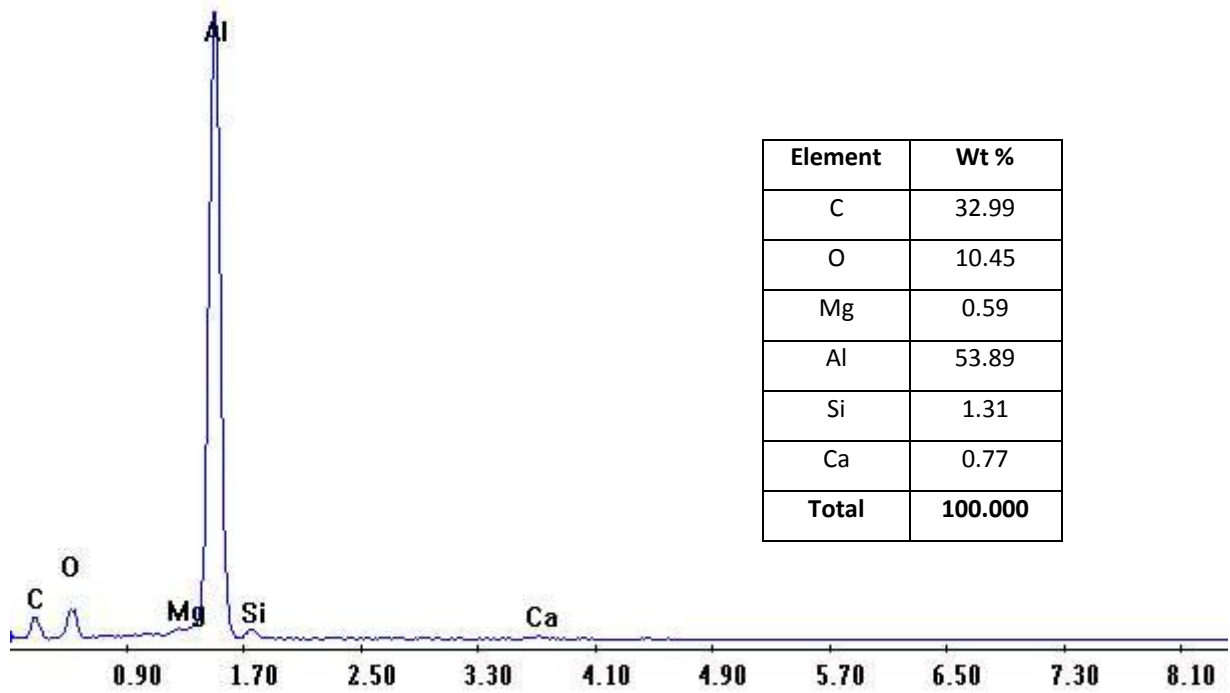
The EDS spectrum obtained from the header surface as seen in Fig. 19 shows some major elements such as aluminum (Al), carbon (C) and oxygen (O). In addition, some other elements were also present such as the alloying elements of the header material: Si and Mg. It can also be seen in Fig.19 that some other elements were also present including sodium (Na), chloride (Cl) and calcium (Ca). The high oxygen content obtained from the results of EDS examination was much likely affected by the oxide formation due to corrosion (as corrosion product). Whereas the high carbon content found in the EDS spectrum was probably very much influenced by oil from the oil cooler. The source of Na and Cl may be caused by some sea water and/or its moisture contamination or may be present in other aqueous environment as a contaminant. Figure 19 also shows EDS spectrum of elements representing the corresponding composition of some inclusion formed inside a large pinhole. Basically the inclusion is a typical aluminum oxide that formed from the filler metal during welding. The aluminum filler metal usually used for welding had higher Si content. Some Na content was also observed in the EDS spectrum as it may be coming from the sea water contamination or marine environment.

EDS spectrum of elements representing the corresponding composition of the fracture weld metal is also presented in Fig. 19. The weld metal in general shows an aluminum alloy containing Si and Mg. The high oxygen content due to oxide scale and high carbon content due to oil contamination was also found from the EDS examination.

effectiveness of the weld joint area. The external corrosion attack would have resulted from the high Cl and/or S levels obtained on the most corroded/fracture surfaces of the failed after-cooler (see Figs. 19, 20 and 21). Chloride is the most important halide ion that has the greatest effect in accelerating attack in most aluminum alloys. The source of this chloride could be coming from the natural constituent of marine environment or from other environments as a contaminant. The external corrosion attack observed in the present study is a typical intergranular or interdendritic corrosion (see Figs 12, 14 and 17). Some aluminum alloys that contain appreciable amount of soluble alloying elements, primarily magnesium, silicon, copper and zinc, are susceptible to intergranular/interdendritic corrosion.

Fig.19. EDS spectrum of elements representing the corresponding composition of header material (at some location as shown in Fig. 18)

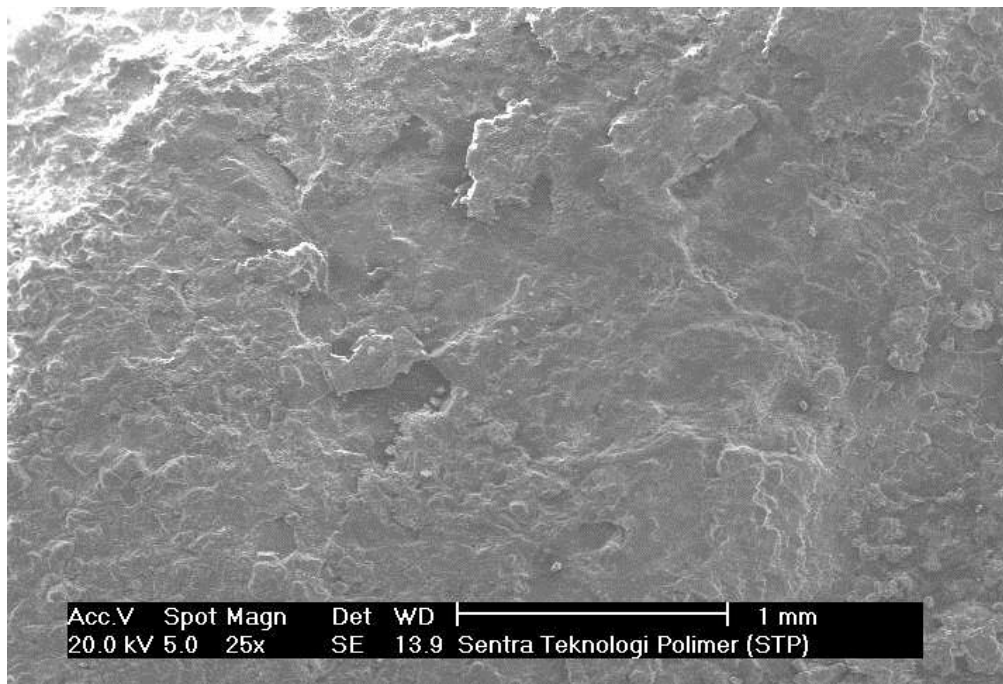
Figure 20 shows SEM photomicrograph obtained from some corroded surface area located around the edge of the header and very much close to the weld surface fracture. The SEM micrograph shows some heavily corroded surface

area that was fully covered with corrosion products. The corresponding EDS spectra of elements representing the composition of the corrosion product obtained from two different locations as seen in Fig. 20 are given in Fig. 21. Most of the results obtained indicated that oxygen (O) and carbon (C) along with aluminum (Al) and its alloying elements such as Si, Mg, Fe, Zn and some sulfur (S), chloride (Cl) and calcium (Ca) were detected on much of the corroded surface scales/corrosion products.

Fig.20. SEM micrograph obtained from some corroded surface area which was located around the edge between the header and the aluminum weld metal.

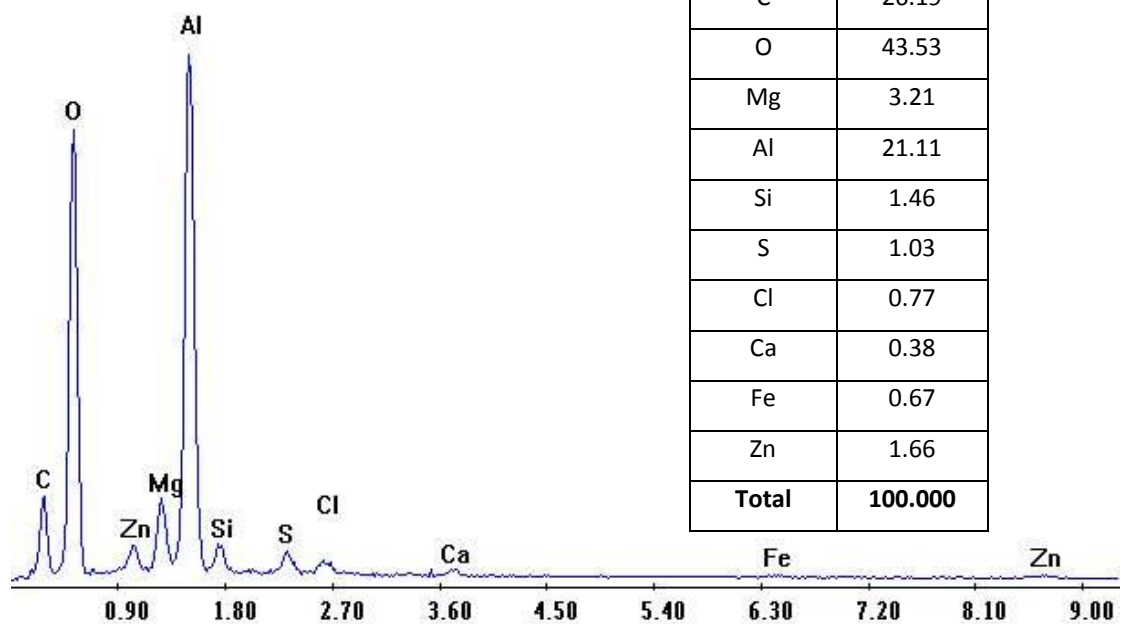
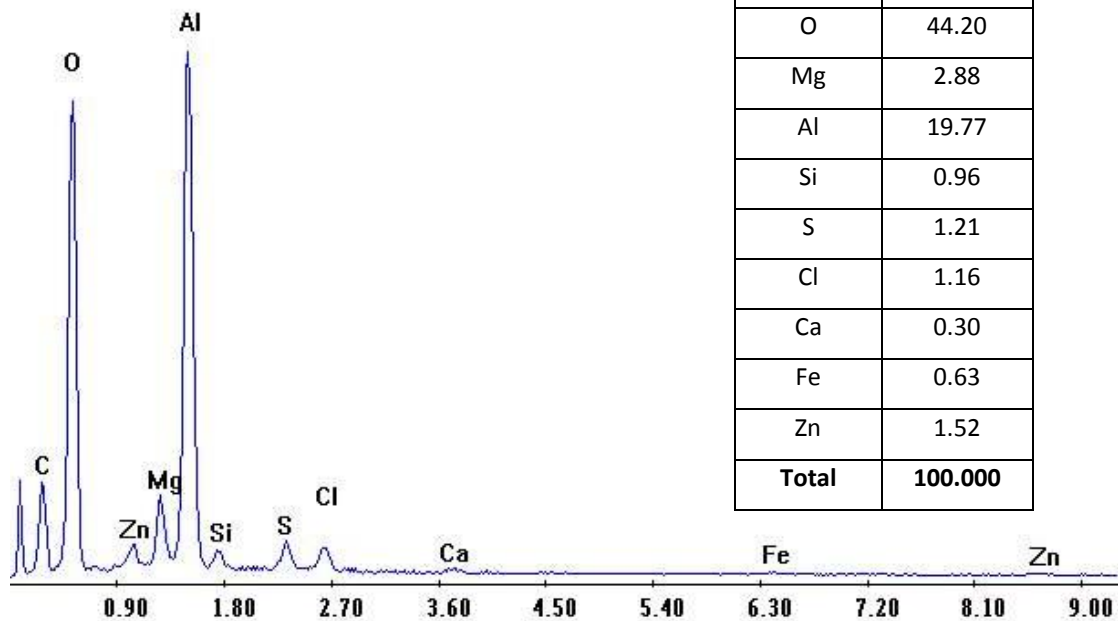
Fig.21. EDS spectrum of elements representing the corresponding composition of some corroded surface area as shown in Fig.20

- The source of Cl and S as contaminants that may have caused external corrosion on some particular area of the after-cooler must be fully investigated in order to avoid any similar accident in the future.
- The weld joint quality between the header and the side bars/parting sheet of the corrugated fins during after-cooler fabrication should be improved to avoid any formation of pinhole (gas porosity) and other welding defects. This may be obtained by improving the application of welding process parameters such as:
