## DAMAGE INVESTIGATION ON WELD ALUMINUM COMPONENT OF A COMPRESSOR AFTER-COOLER

**Dewa Nyoman Adnyana**

#### Studi Kerusakan Sambungan Las Komponen Aluminium Sebuah Alat Penukar Kalor Kompresor

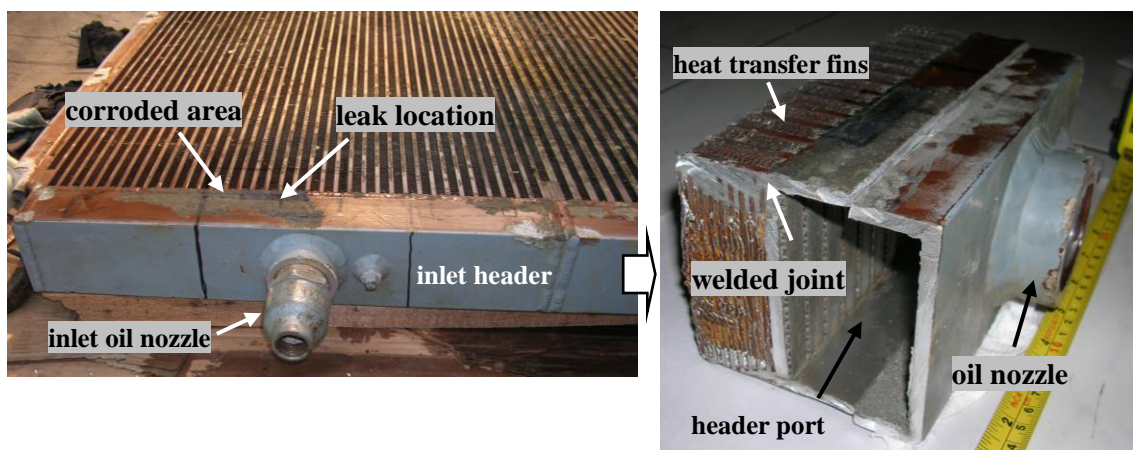
Figure 2. Cutting-off some parts of the compressor after-cooler around the leak location for samples preparation

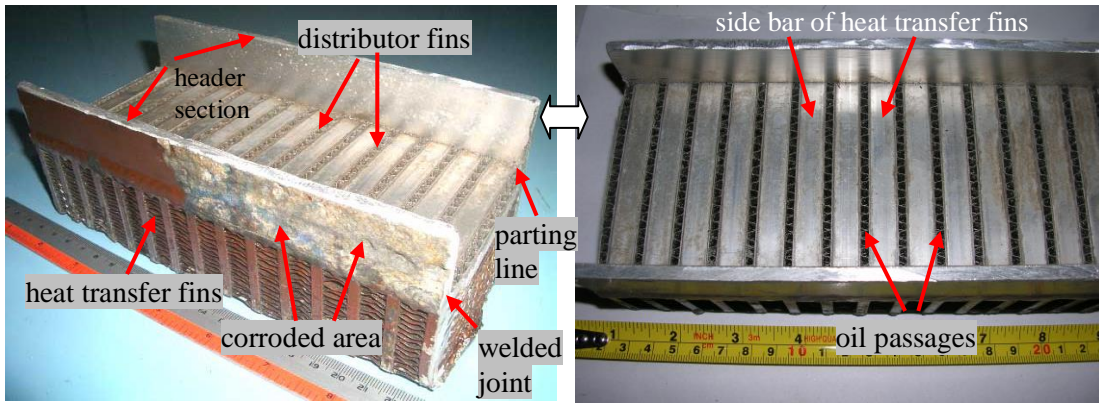
Figure 3. Close up view of the inside header port, showing a number of oil passages containing distributor fins and parting line of the weld joint between header and side bars/parting sheets.
